VAN'S AIRCRAFT, INC.

## NOTIFICATION 05-17-11

**Subject:** Cracking in Stabilator Nose Ribs

**Affected Models:** RV-12 EMP/CONE Kits and individual parts shipped between November 5, 2010 and May 5, 2011.

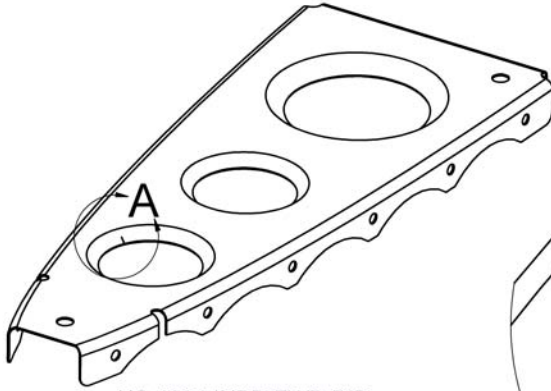
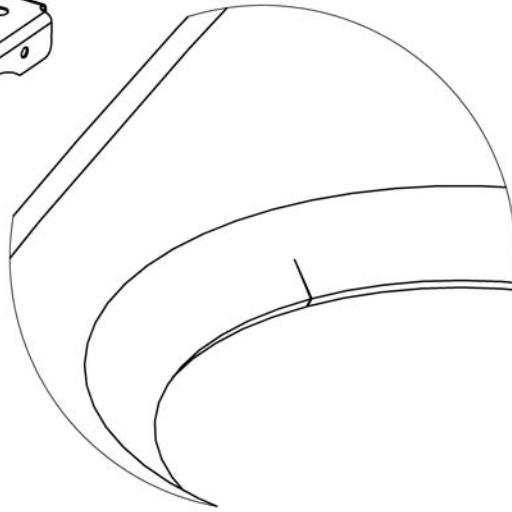
DETAIL A

Prior to installation, customer found crack in stiffening flange of HS-1204 FWD INBD RIB. Structurally these cracks do not present a safety of flight risk. However, builders are encouraged to inspect affected parts and to take corrective action if cracks are found.

HS-1204 INBD FWD RIB  
SHOWN CRACKED

Repair by stop drilling using #40[2.5mm] drill bit.

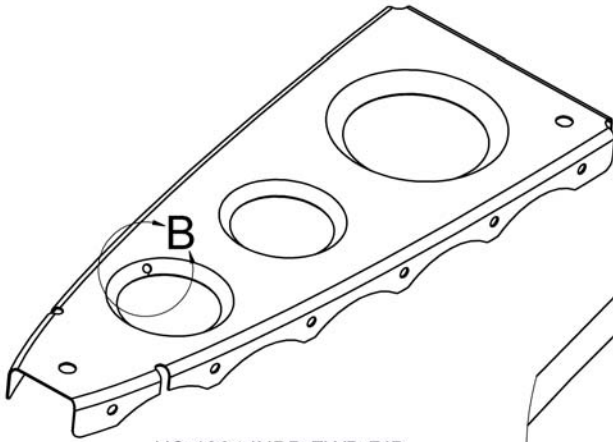
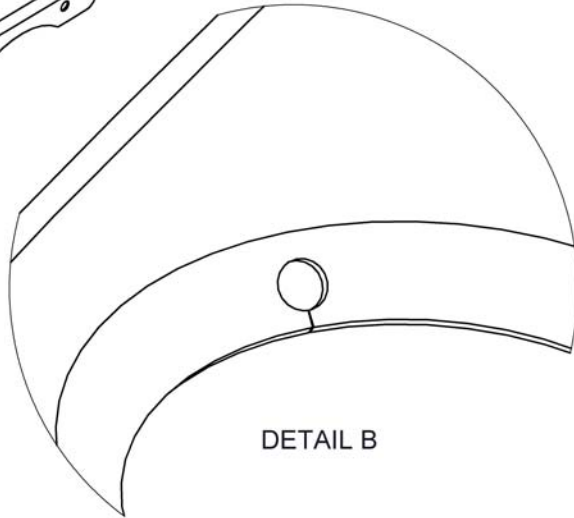
DETAIL B

HS-1204 INBD FWD RIB  
SHOWN STOP-DRILLED #40
