# TOTAL PERFORMANCE VAN'S AIRCRAFT

## NOTIFICATION 15-10-01

**Date Released:** October 1<sup>st</sup>, 2015  
**Date Effective:** October 1<sup>st</sup>, 2015  
**Subject:** Flap Handle Button Actuation Force  
**Affected Models:** All RV-12's  
**Required Action:** Modify the flap handle spring  
**Time of Compliance:** None  
**Supercedes Notice:** N/A  
**Labor Required / SLSA Warranty Allowance:** .5 Hours / None  
**Level of Certification:** LSA Repairman Maintenance, A&P

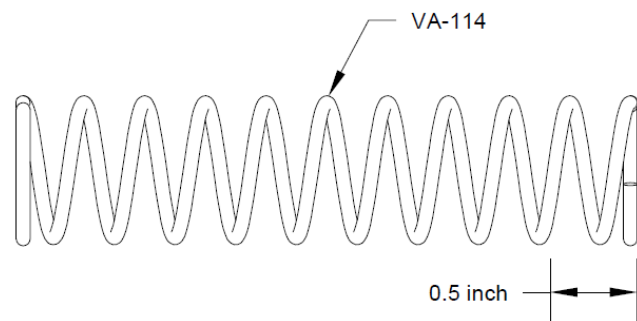
**FIGURE 1: COMPRESSION SPRING MODIFICATION**

This notification explains how to shorten the VA-114 Compression Spring to allow a lower force required for actuating the flap knob.

Step 2: Choose one end of the VA-114 Compression Spring and make a mark on the spring per the dimensions in Figure 1.

Cut the spring at the mark and discard the small piece. A die-grinder with a small cutoff disc works very well for making this cut.

**NOTE: When installing the shortened compression spring into the WD-1213 Flap Handle, orient the cut side of the spring facing down the flap handle.**
