VAN'S AIRCRAFT

NOTIFICATION 16-08-10

Subject: Soft Engine Isolators

RV-12 ELSA aircraft that received a Powerplant Kit between July 1, 2015 and June 30, 2016.
RV-12 SLSA aircraft serial numbers 12061-12070.

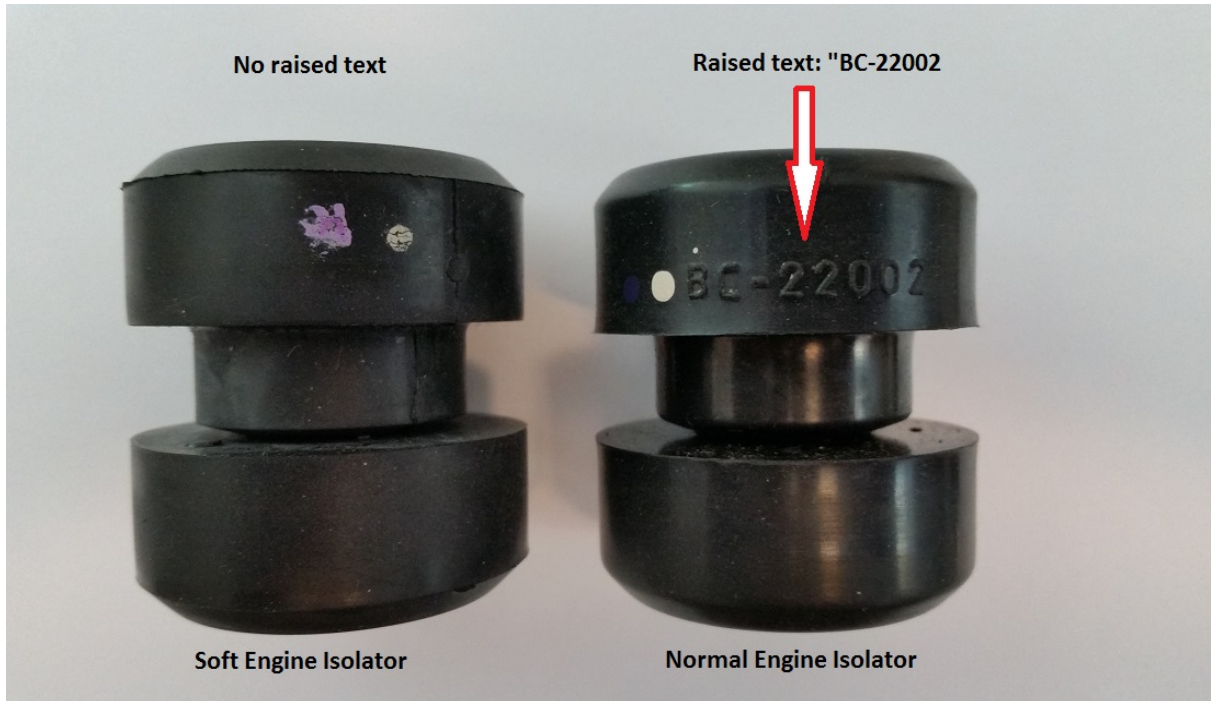
FIGURE 1: ENGINE ISOLATOR IDENTIFICATION

Soft engine mount isolators were supplied that allow greater than normal engine movement.

If the isolator has the text "BC-22002" as shown in the figure below on at least one half of the isolator the correct isolators are installed. Make a logbook entry noting compliance with this notification and place a copy of this notification in the back of the Maintenance Manual.

If the isolator has no text as shown in the figure below contact Van's Aircraft for a replacement engine isolator set. Replace the isolators using KAI Section 46 as reference. Make a logbook entry noting compliance with this notification and place a copy of this notification in the back of the Maintenance Manual.

Required Action: Check isolator type and replace if necessary
