# VAN'S AIRCRAFT, INC.

## NOTIFICATION

- Date:** August 16, 2012
- Subject:** Rotax Oil Reservoir fittings
- Affected Parts:** Oil Reservoirs shipped with Rotax 912ULS engines, RV-12 Powerplant Kits.
- Synopsis:** It has come to our attention that at least two Rotax engines shipped with RV-12 Powerplant Kits included oil reservoirs with incorrect fittings attached. The two main fittings on the top of the oil reservoir should be male flare type fittings. Incorrect reservoirs were shipped from Rotax with female flare fittings. The Van's supplied oil lines will attach to the incorrect fittings but will not seal and will result in oil leaks.

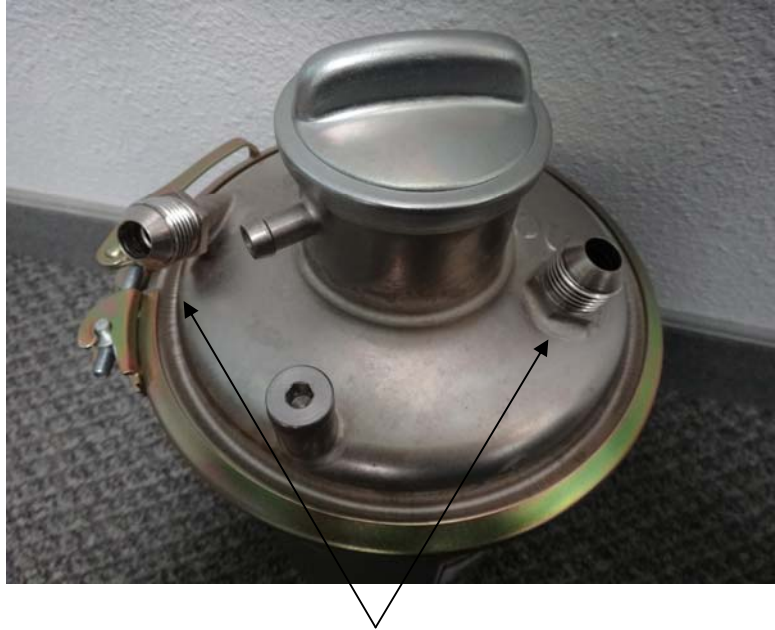
**Correct Fittings**

1. Remove the top cowl to gain access to the oil reservoir.
2. Remove one of the main oil lines attached to the top of the oil reservoir.
3. Inspect the fitting(s) on the top of the oil reservoir. Fittings should be male flare fittings...see photo of correct fittings.
4. If fittings are correct, reinstall the oil line and top cowl.
5. If fittings are incorrect, contact Van's Aircraft to receive a replacement reservoir.

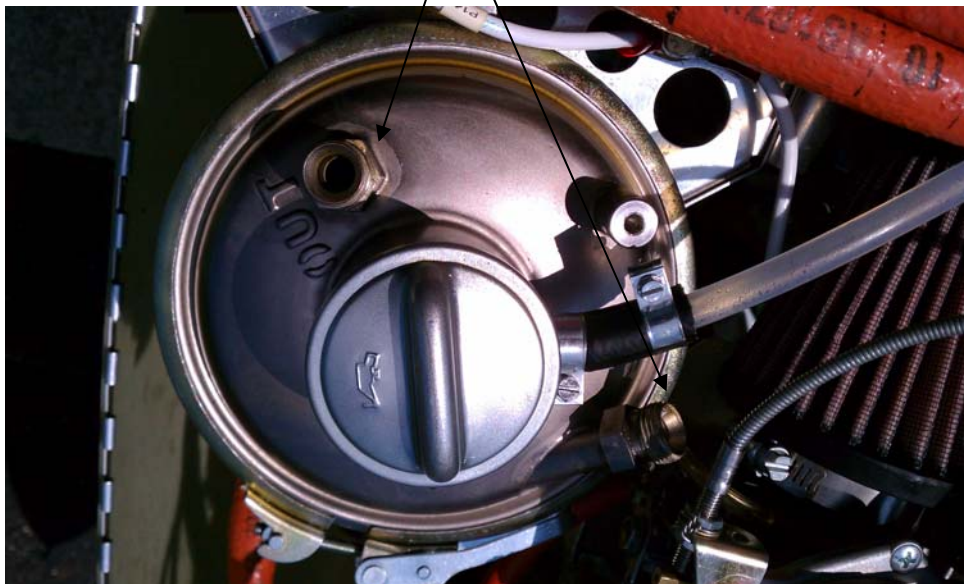
**Incorrect Fittings**
