# *VAN'S AIRCRAFT, INC.*

SERVICE BULLETIN NUMBER: 04-3-1

APPLICATION: Electric flap drive motors.

SUBJECT: Multiple holes in attach lug.

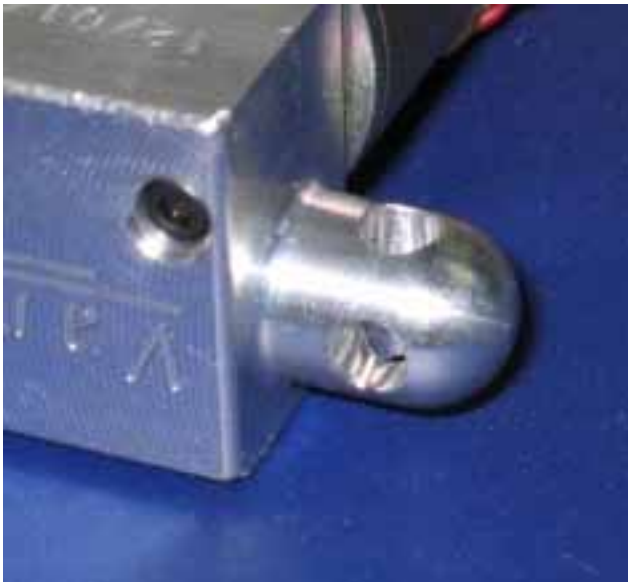
The manufacturer of the motor/drive assembly used in all RV electric flap installations is recalling some flap motor/flap drive assemblies. The actuator arms of these components have been drilled with two holes at right angles, instead of the intended single hole (see illustration).

Although no service difficulties arising from this aspect of the electric flap installation have ever been reported to Van's Aircraft, Inc., we are requesting the return of all such electric flap motor/drive assemblies. Replacement flap actuators are available at a discounted price, with the return of the cross-drilled actuator.
