Re: Service Bulletin 08-6-1 applicable to all Van's RV-10 kits and completed aircraft

Service Bulletin 08-6-1

Subject: F-1010 bulkhead reinforcement

Affected Models: RV-10

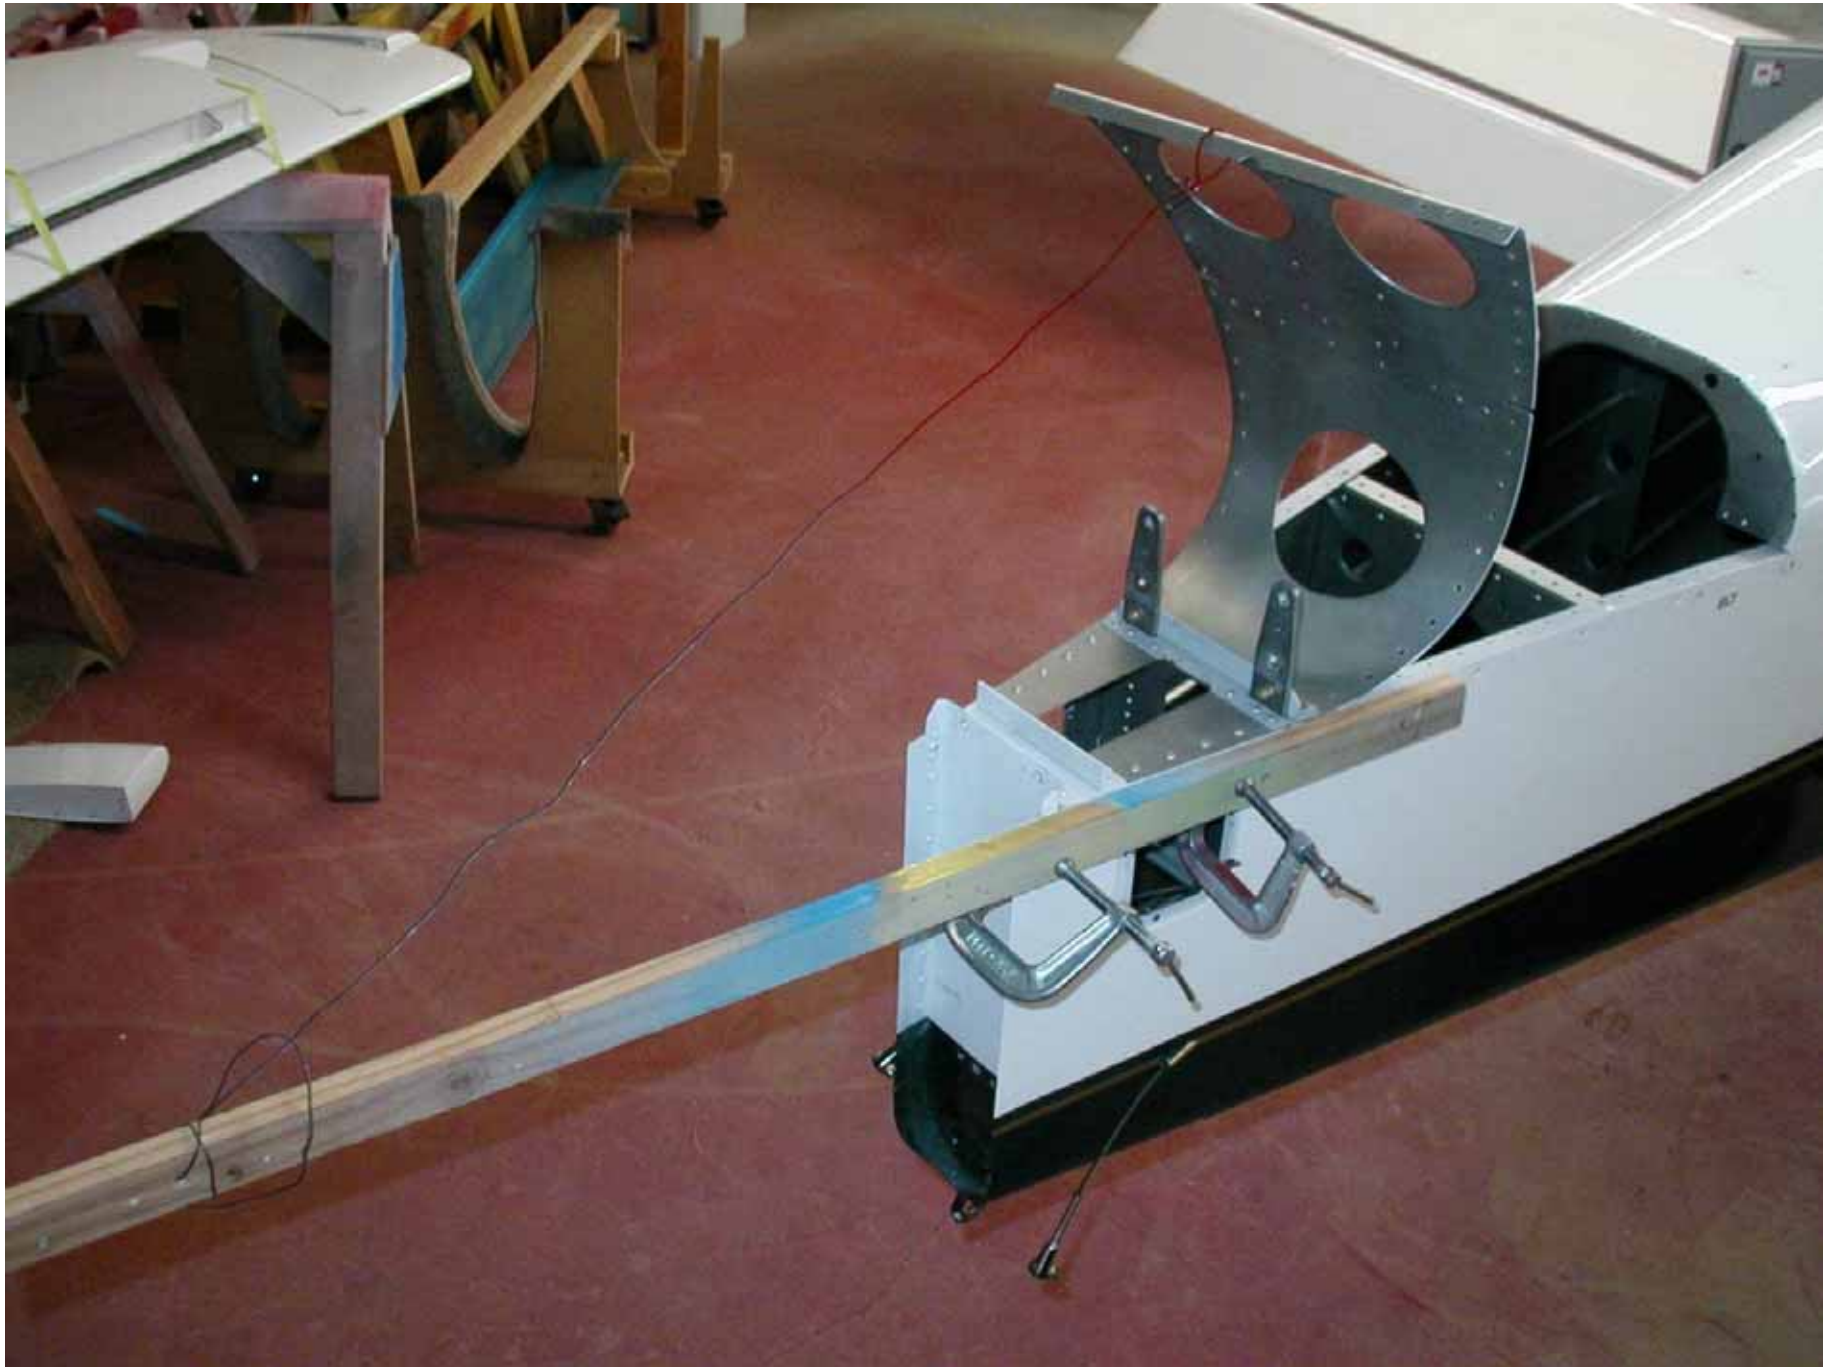
Empennage has been removed. The aft deck is held open and out of the way with this simple setup.

Step 7: As shown in Figure 3, pull back the F-1014 Aft Deck and secure it in position with a rope, wire, etc.

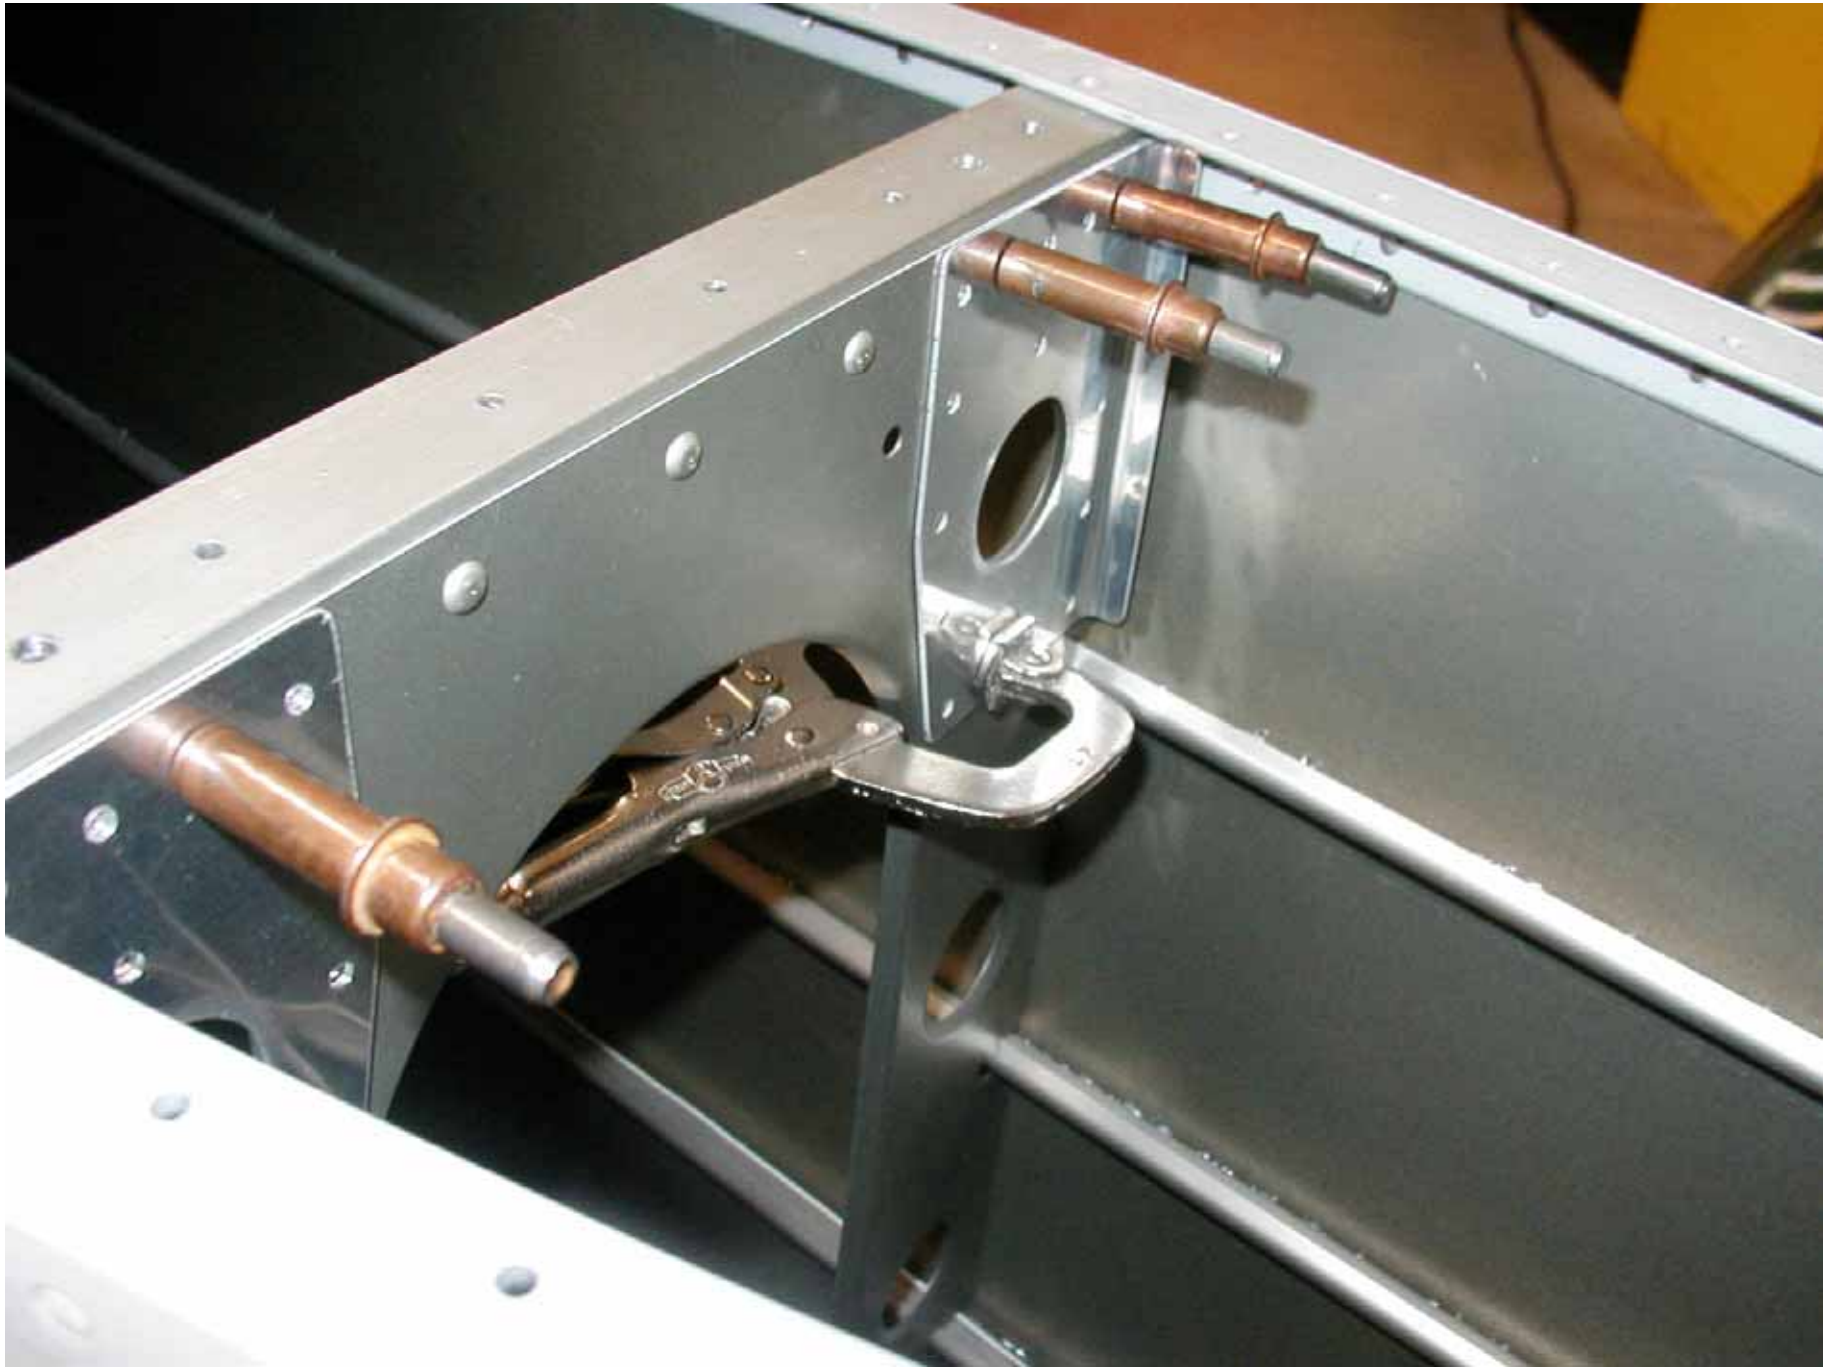
Doublers clecoed/clamped in place after match drilling.

Step 12: Match-Drill #30 all of the holes of the F-1010C-L & -R Bulkhead Doublers into the F-1010 Bulkhead and F-1010A Horizontal Stabilizer Attachment Angle. Be careful to drill square to the bulkhead, particularly when drilling into the angle. The reflection of the drill bit in the bulkhead doublers can be helpful.

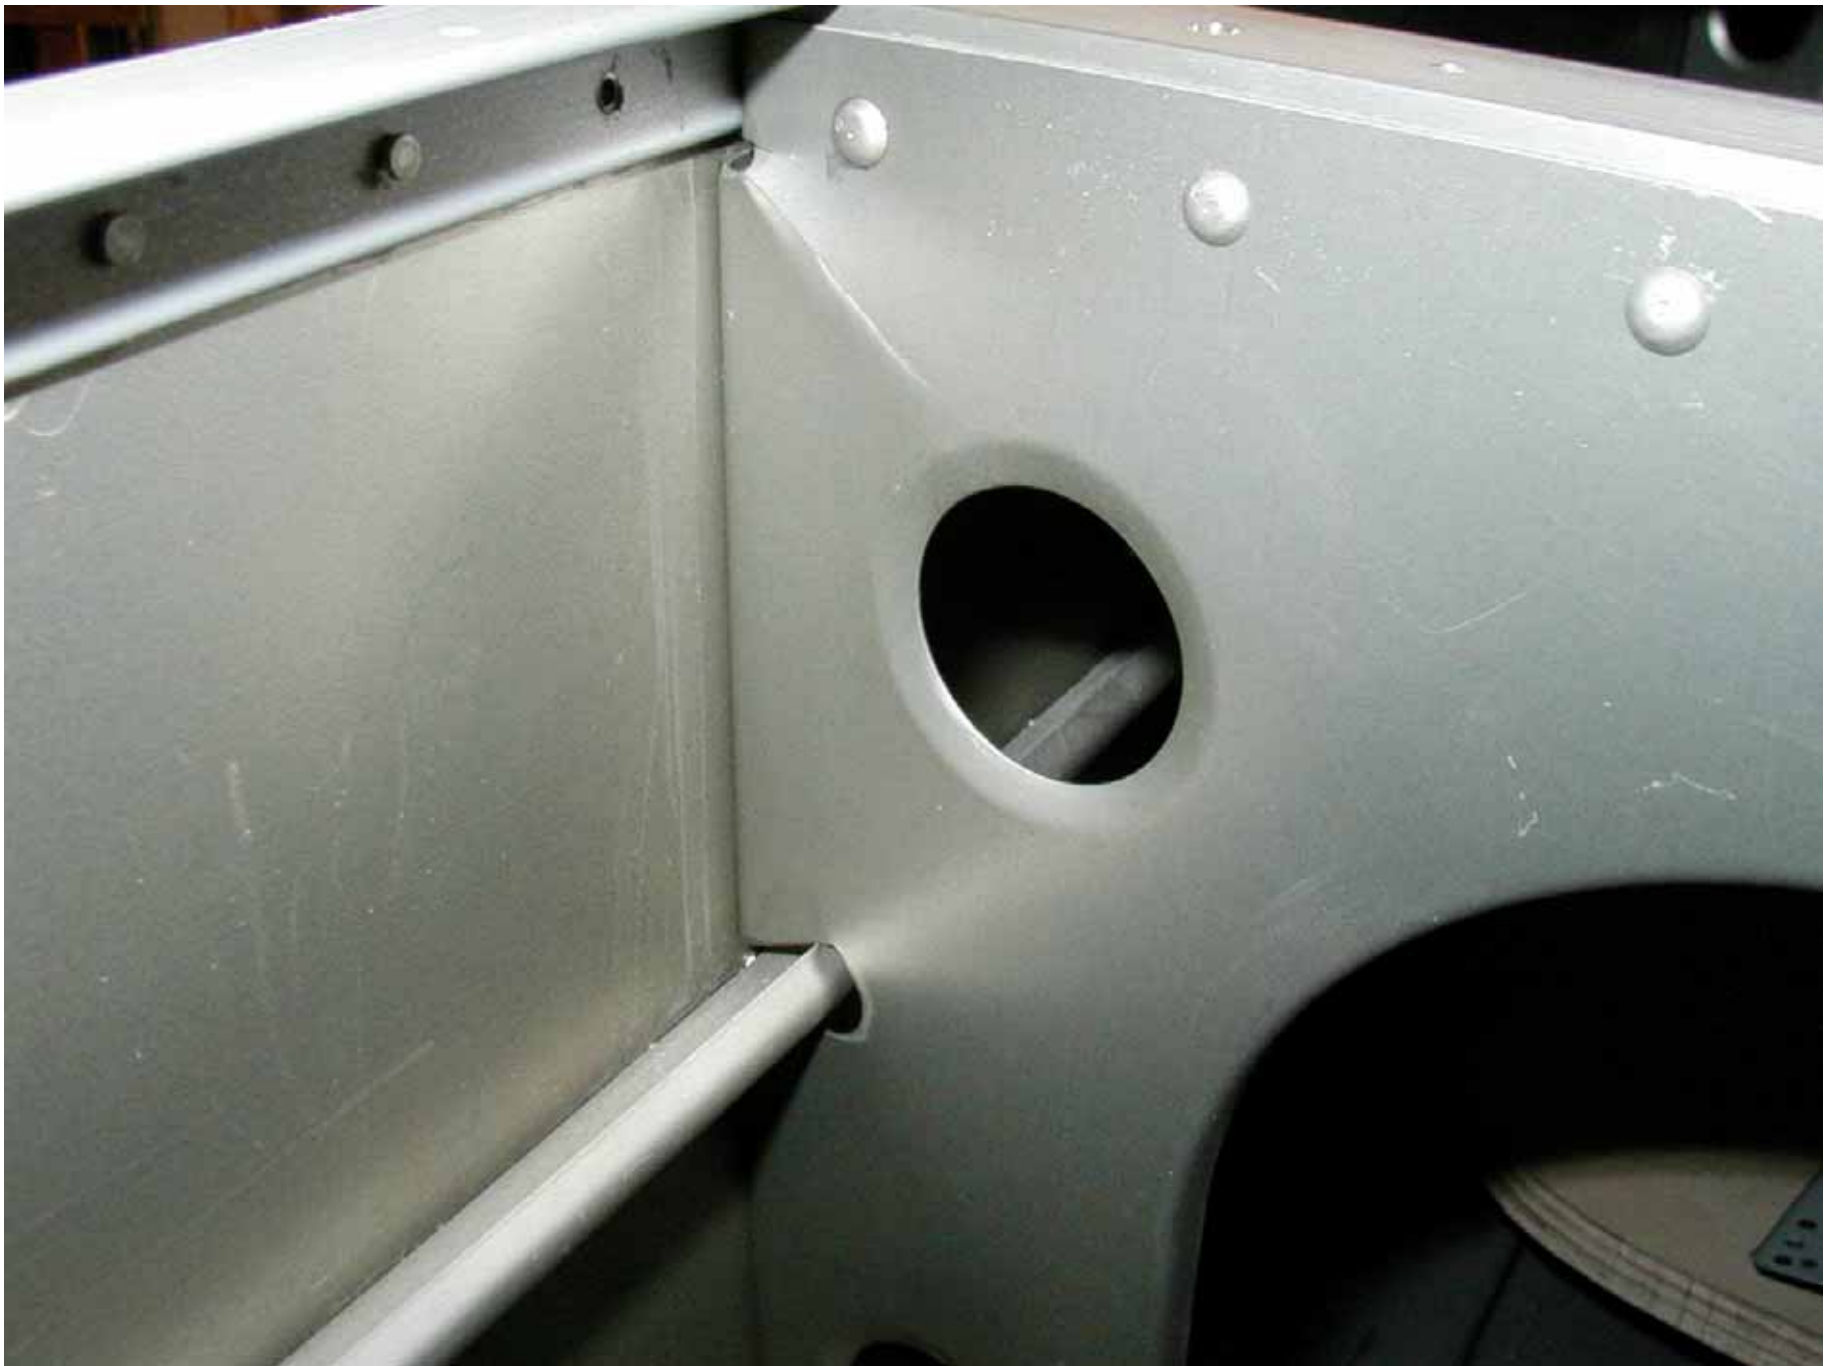
Synopsis: A crack was discovered on the F-1010 bulkhead on Van's RV-10 demonstrator aircraft at ~500 hours time in service. The F-1010 bulkhead is integral in the attachment of the forward spar of the horizontal and vertical stabilizers. Inspection of the F-1010 bulkhead should be accomplished in order to determine the integrity of the bulkhead. If no crack is found, recurrent inspections should be accomplished until F-1010C doublers are installed during the next annual condition inspection. If a crack is found during inspection, F-1010C doublers should be installed prior to further flight in accordance with the instructions outlined in this bulletin.

Crack in the upper left corner of F-1010 bulkhead....as seen from the back side looking forward.

Required Action: Inspect F-1010 bulkhead for cracks
Install F-1010C bulkhead reinforcing doublers

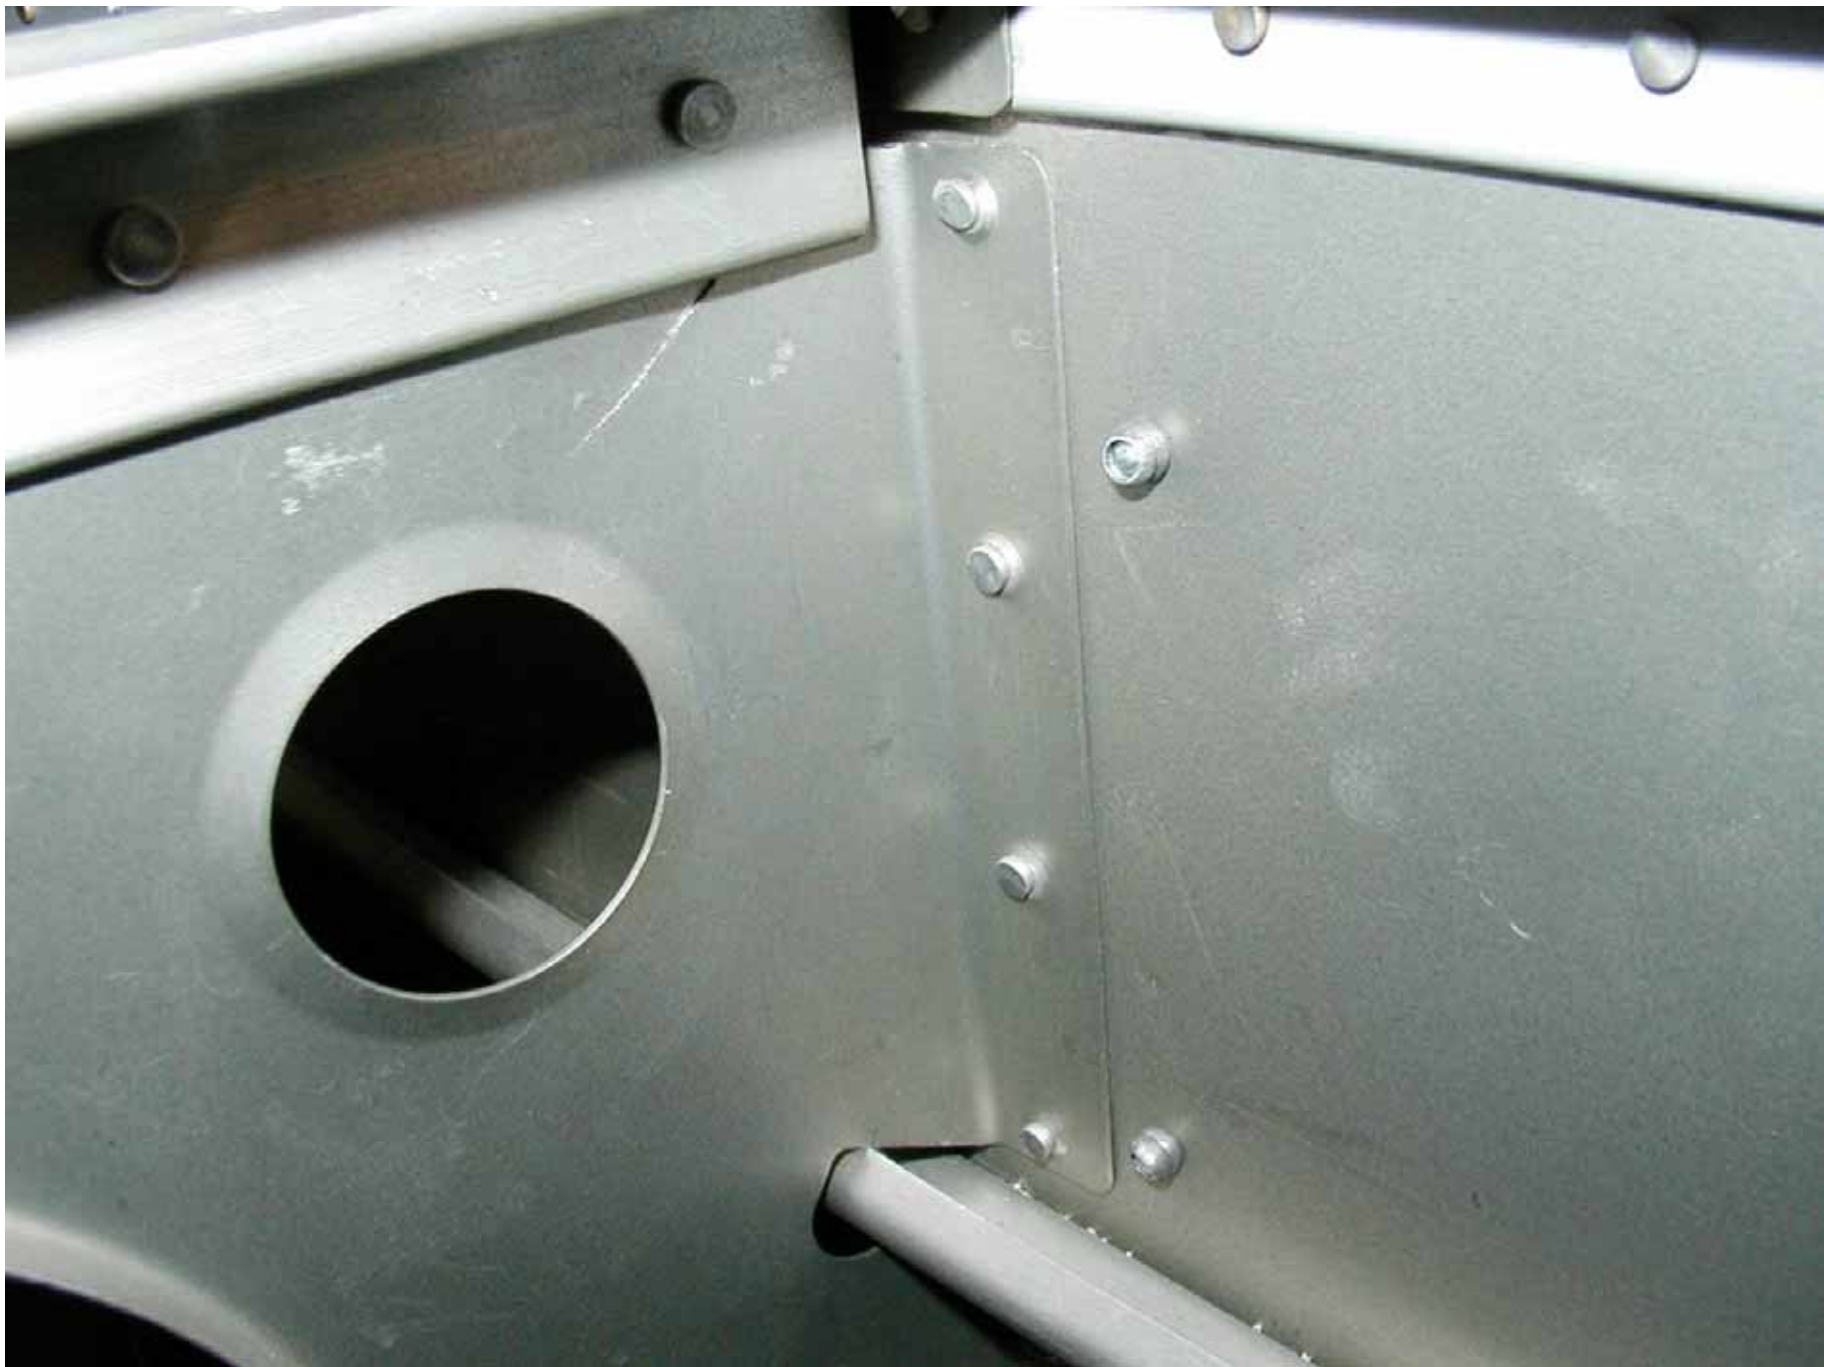
Crack in the upper left corner of F-1010 bulkhead....as seen from the front side looking aft.

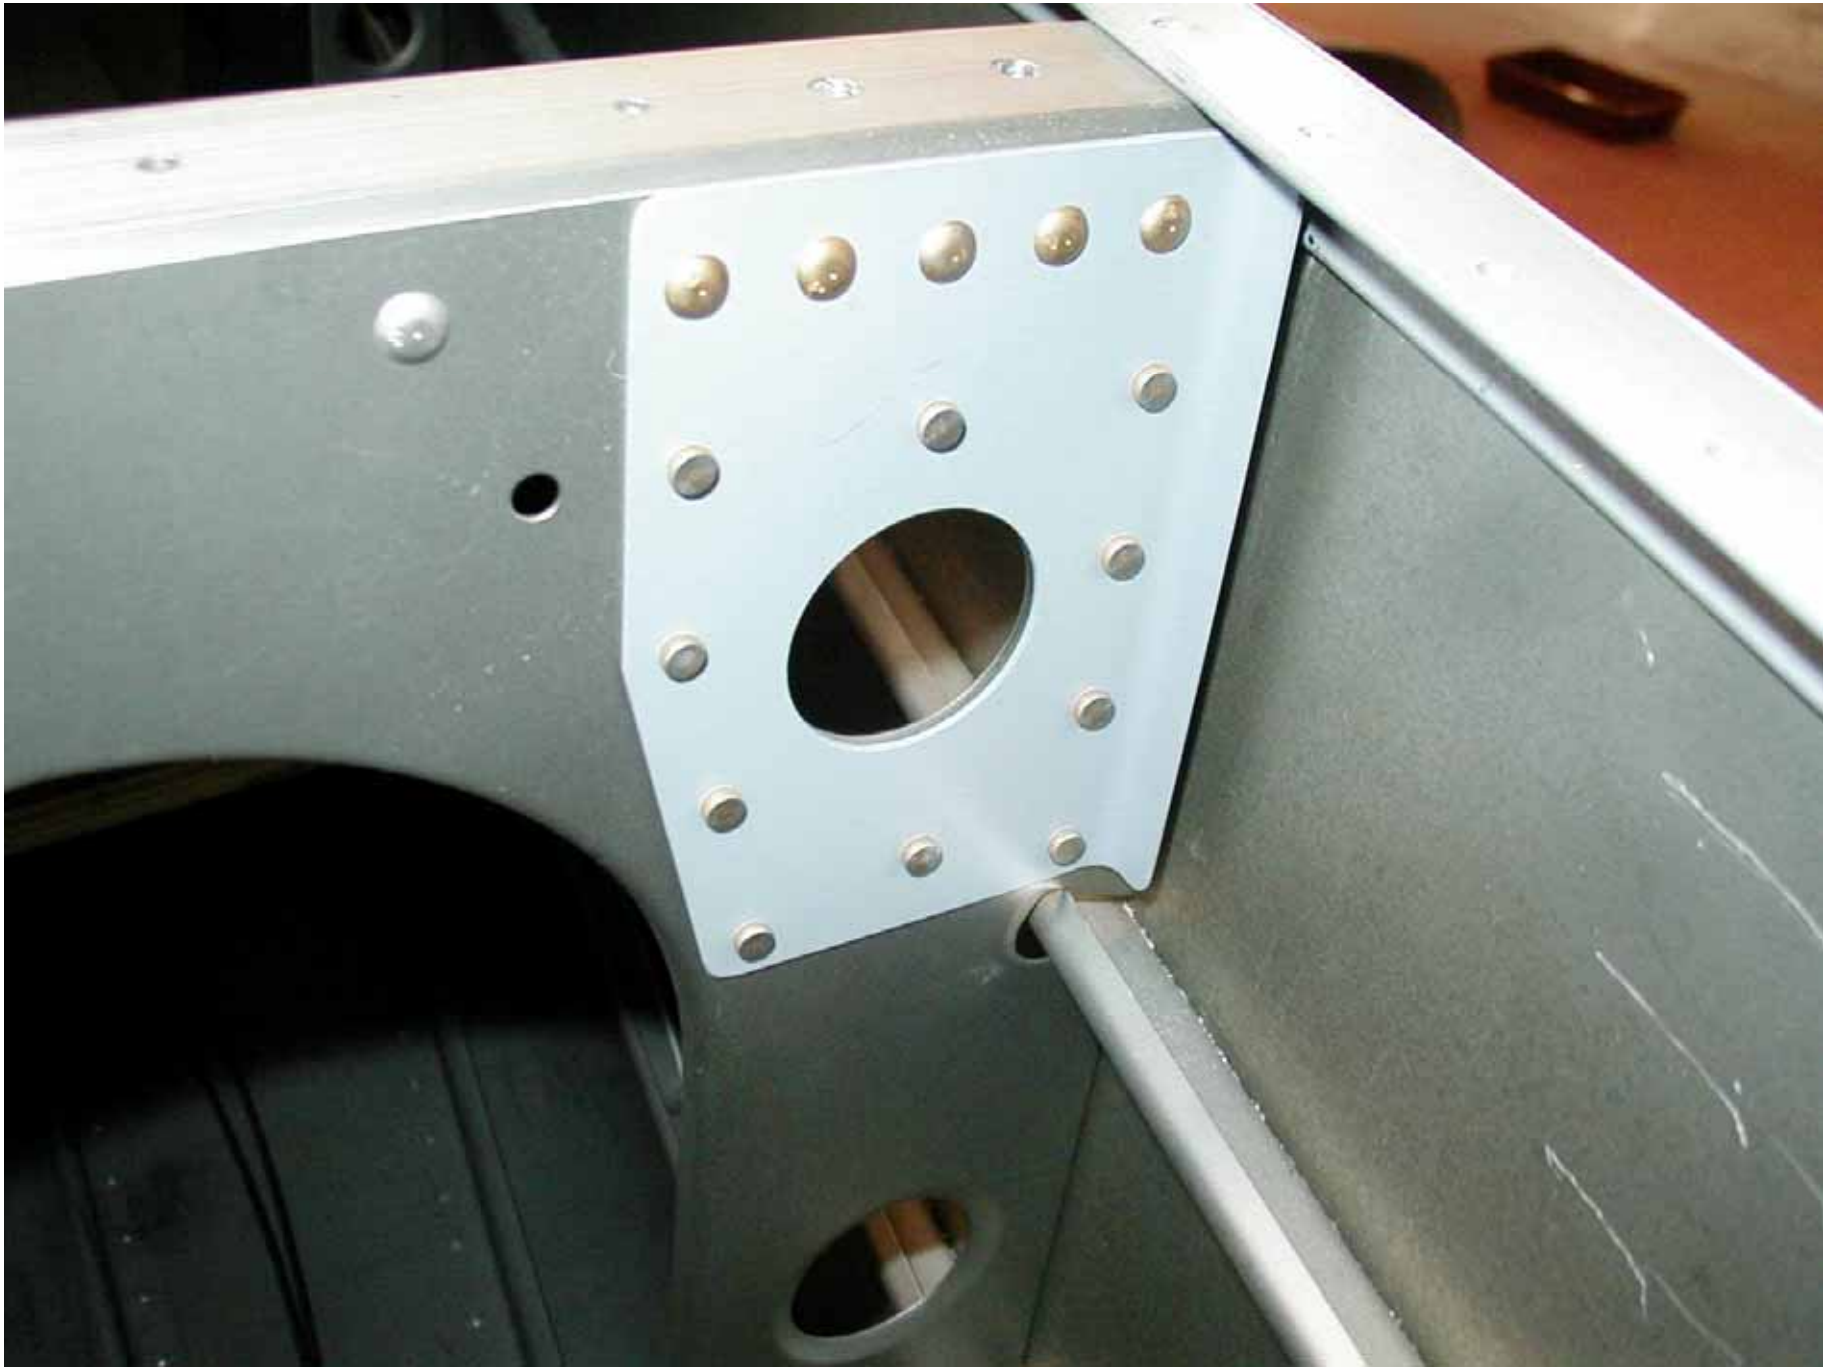
F-1010C doubler riveted in place.

Step 14: Rivet the F-1010C-L & -R Bulkhead Doublers to the F-1010 Bulkhead and F-1010A Horizontal Stabilizer Attachment Angle using the rivets called out in Figure 4.
