VAN'S AIRCRAFT, INC.

SERVICE BULLETIN 10-04-28

- Date Released:** April 28, 2010
- Date Effective:** Immediately
- Affected Models:** RV-12 (Wing Kits shipped between Jan 1, 2010 and April 26, 2010)
- Required Action:** Inspect W-1208 nose ribs for cracks along reinforcing beads.

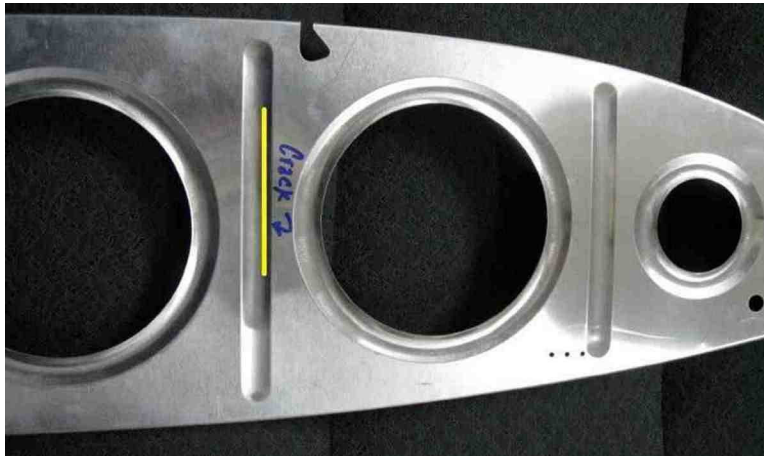
- Time of Compliance:** Before further assembly / Before next flight
- Synopsis:** Cracks have been reported along the straight reinforcing beads on W-1208 wing ribs.

- Method of Compliance:** Inspect all W-1208 nose ribs along the straight edges of the reinforcing beads for cracking. If ribs are installed and wing is skinned, the inspection can be performed using a flashlight and extended inspection mirror to view through the lightening holes. Outboard ribs can be inspected by removing the flaperon from the wing and inspecting through the outboard lightening holes in the rear spar.

- Replacement Procedures:** Contact Van's Aircraft for replacement ribs and/or further instructions should any cracked ribs be found.
