VAN'S AIRCRAFT, INC.

SERVICE BULLETIN 12-09-26

Subject: Loose U-1202 Attach Bolts

Affected Models: All RV-12 Models

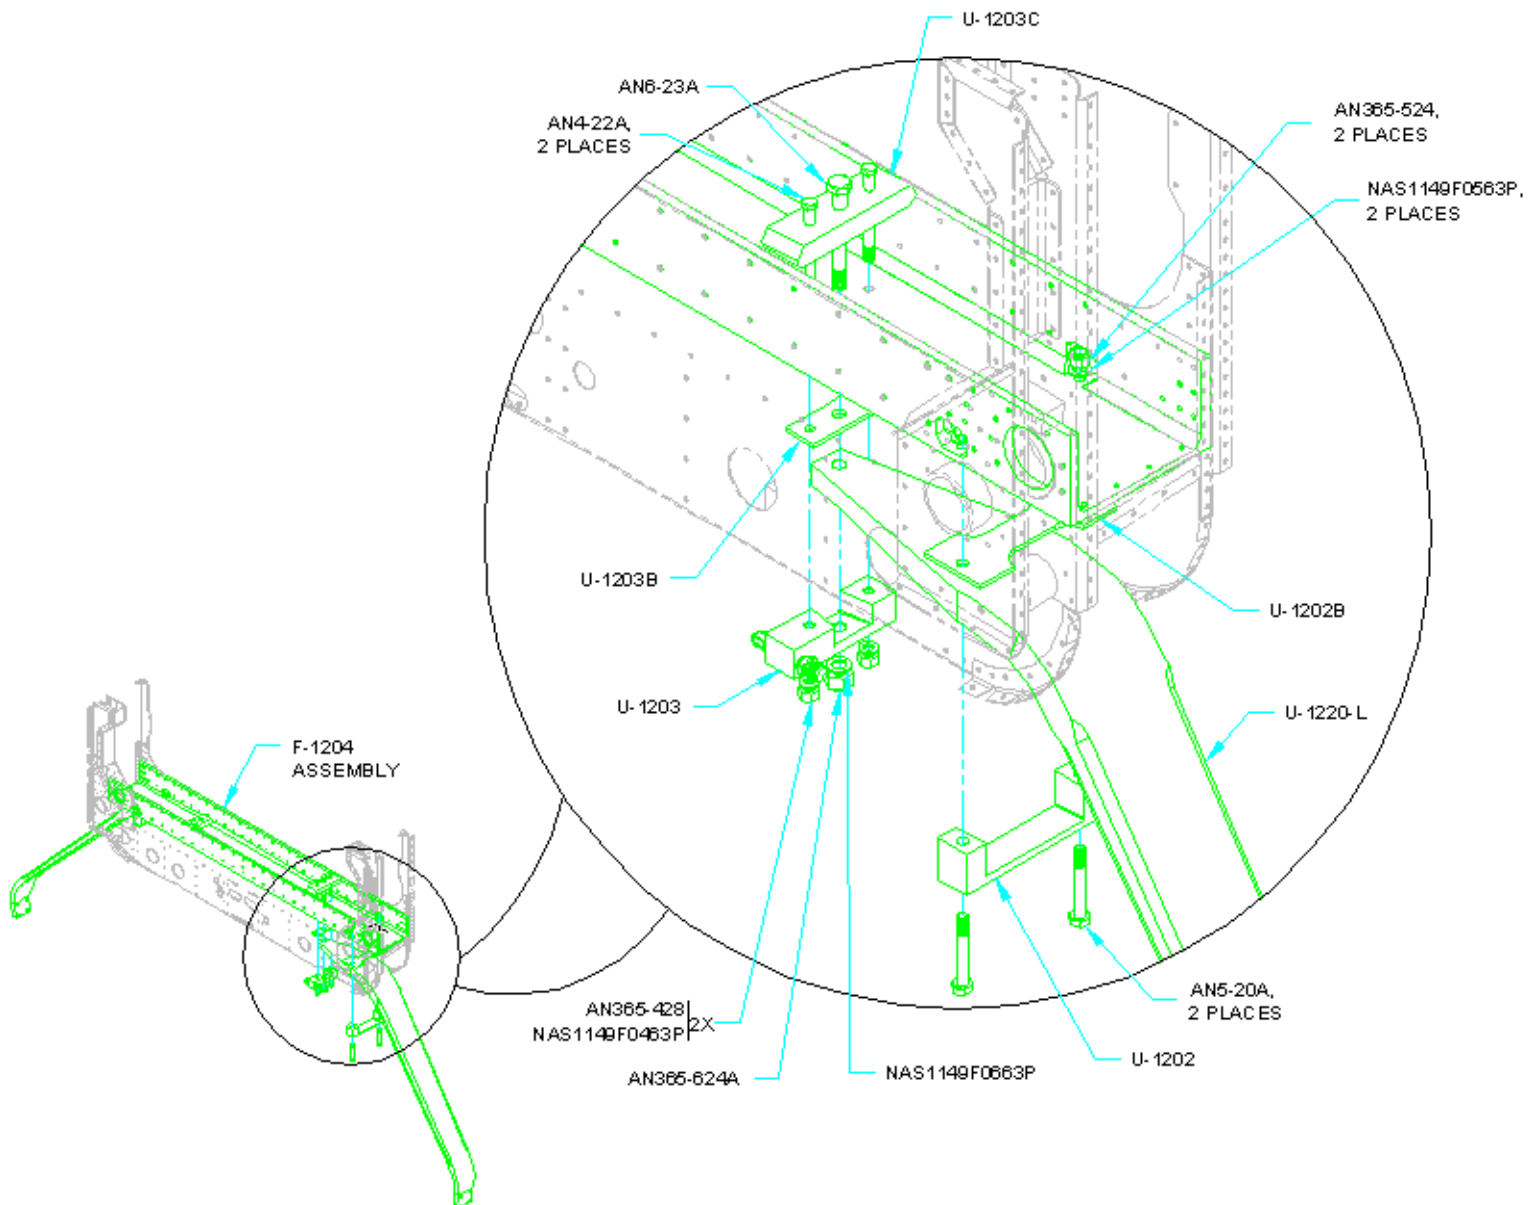
The AN5-20A bolts used to attach the U-1202 Outbd Main Gear Attach Bracket may be improperly seated and torqued during initial installation resulting in loose fasteners and possible damage to the landing gear and aircraft structure. As of the date of this bulletin, Van's is actively evaluating this issue to determine if other factors may be relevant.

Remove the AN365-524 nuts and NAS1149F0563P washers that attach the landing gear, U-1202B Outboard Wear Plate and U-1202 brackets. Check the F-1204 Center Section Assembly for cracks around each hole. Check the surrounding area near the cutouts made in center section for the nuts. If cracks are present, do not fly the aircraft and contact Van's for repair information.

If cracks are not present, replace the washers and nuts. Re-torque each nut to the normal value 100-140 in lb plus the prevailing torque (the torque required to turn the nut onto the threads of the bolt. Determine this by holding the bolt stationary and measuring the torque required to turn the nut onto the bolt. All the threads of the nut should be engaged with the threads of the bolt).

Check that the bolt is fully seated prior to torquing the nut/bolt by tapping it with a hammer (protect the bolt head with a wood block), rather than relying on the nut drawing the assembly together. Round off the lower forward corners of the U-1202 if/as required to remove any interference with rivets used for attaching the F-1225-L & -R Seat Floors to the F-1204 Center Sections Assembly. Prime areas where powder coat is removed.

Use an even torquing sequence working back and forth between each of the bolts attaching the U-1202 until the final torque is achieved. Check that the U-202 is holding the gear leg evenly on both sides. Once final torque is achieved re-seat the bolt once again with a hammer and wooden block to protect the bolt head and make a final check of the torque.

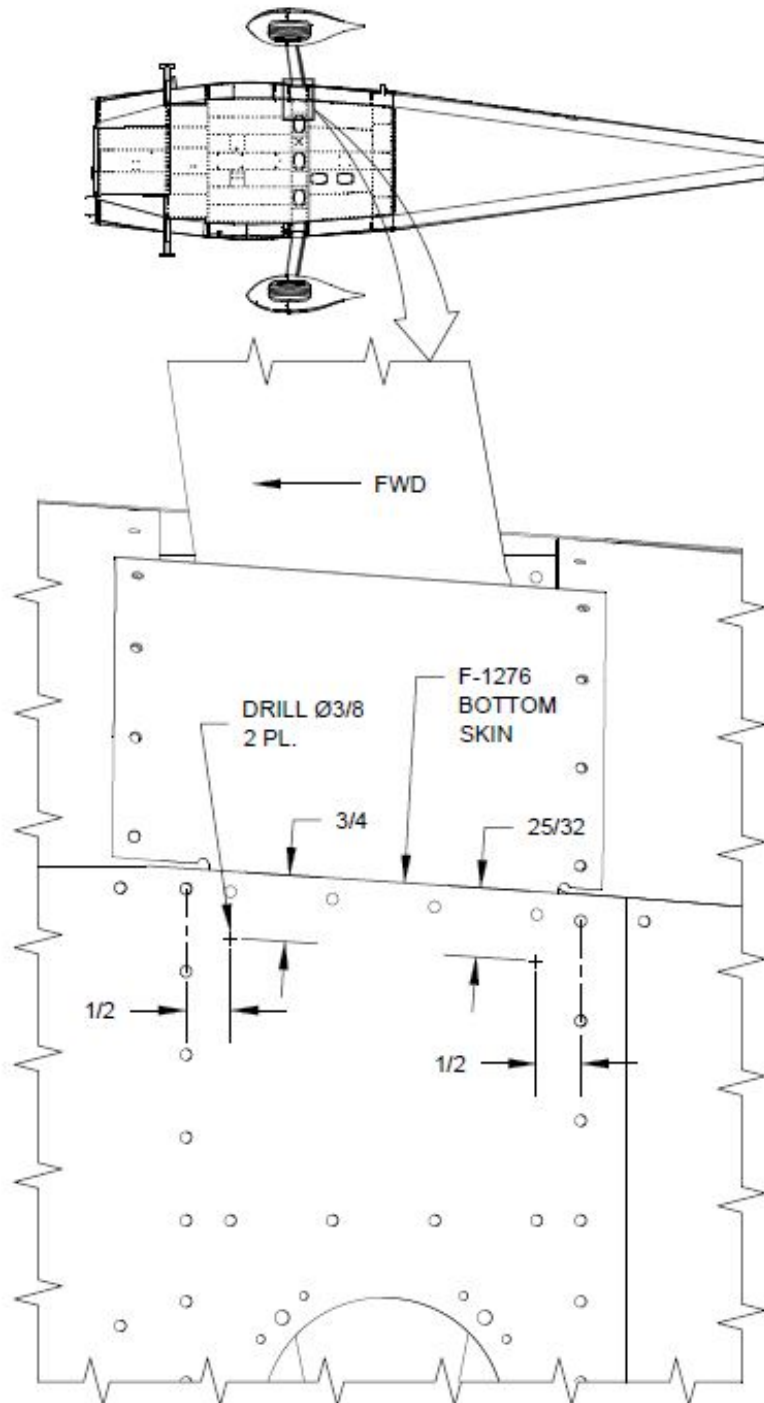
FIGURE 1: DRIFT ACCESS HOLES
BOTTOM VIEW - LEFT SIDE

In order to properly seat a U-1202 Main Gear Attach Bracket bolt a brass drift may be used on the head of the bolt. This requires access to the head of each bolt which may be gained in one of two ways.

The first option is to drill $\frac{3}{8}$ dia. [9.5mm] holes in the F-1276 Bottom Skin to allow for insertion of the drift. See Figure 1. This still permits torque to be applied to the head of the bolt, if desired, since a socket extension may be inserted through the new hole before the socket itself is attached.

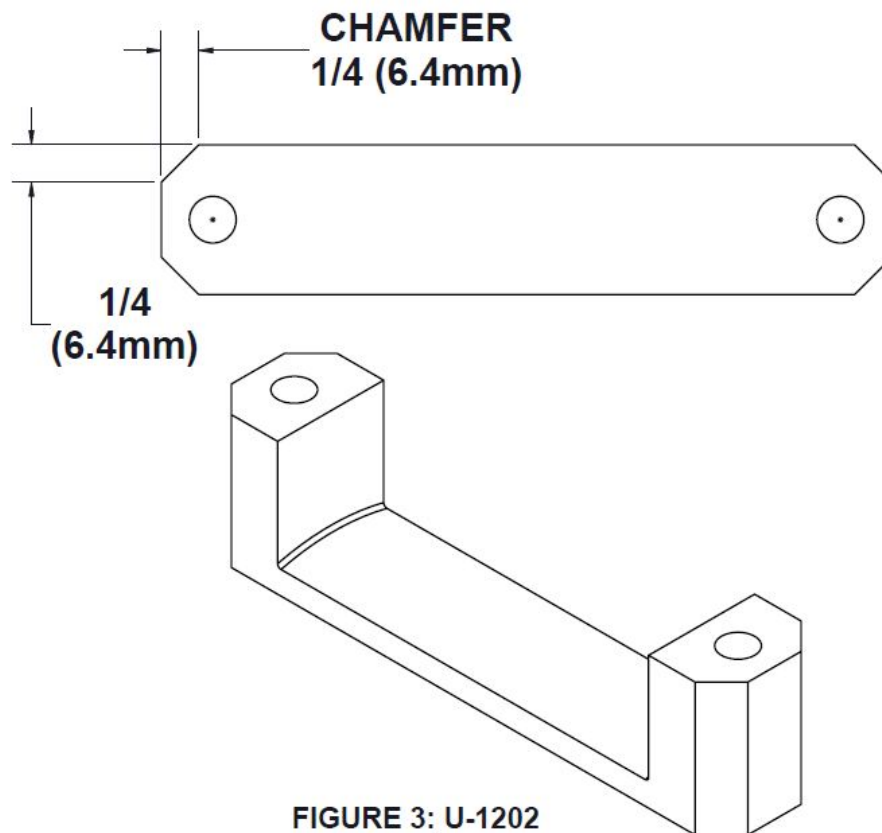
The sentence; "Round off the lower forward corners of the U-1202 if/as required to remove any interference with rivets ..." has been changed to read; "Chamfer the four corners of the U-1202 to remove interference with rivets ..."

See Figure 3 for chamfer locations and dimensions.
