## SERVICE BULLETIN 14-12-22

**Subject:** WD-631-PC Nose Stop Flange installation orientation

**Affected Models:** RV-6A,7A,8A,9A,10

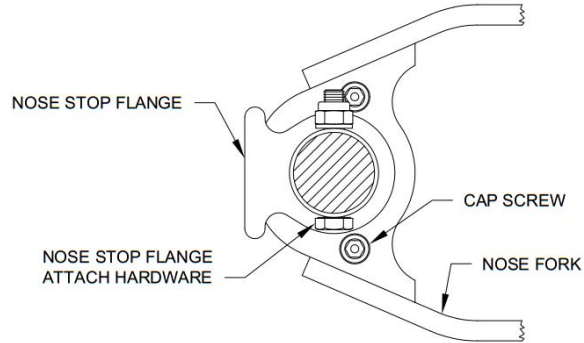
**CORRECT INSTALLATION  
IN TRAIL  
(VIEW FROM ABOVE)**

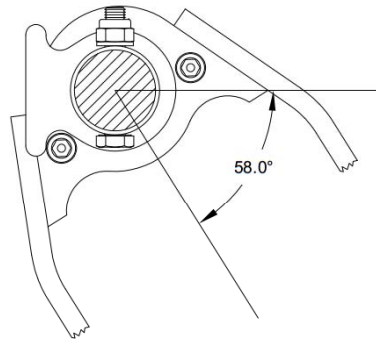
**CORRECT INSTALLATION  
FULL RIGHT TURN**

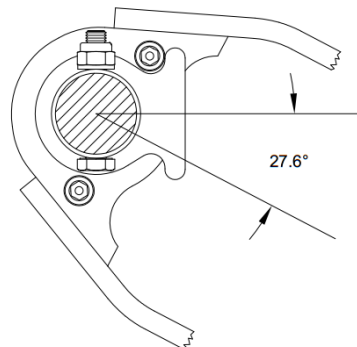
**FIGURE 1:** Nose Gear Range of Travel

Van's Aircraft has received reports of damage resulting from the WD-631-PC or WD-1031 Nose Stop Flange (stop flange) having been oriented incorrectly during installation. If the stop flange is installed incorrectly, it will allow insufficient rotation of the nose fork during tight taxi turns and can cause the tire to drag sideways. This induces excessive loads on the stop flange, nose gear leg, engine mount and the associated attach hardware. The 'arms' of the stop flange should be oriented forward, not aft. See Figure 1 and Figure 2. If the stop flange is oriented with the 'arms' aft, it is installed incorrectly.

**INCORRECT INSTALLATION  
FULL RIGHT TURN**

Step 3: Remove and discard the hardware that holds the stop flange to the nose gear leg. See applicable drawings for the aircraft type being inspected. Inspect the stop flange for damage.

Step 4: Re-Install a serviceable stop flange in the correct orientation using new hardware. See Figure 2.

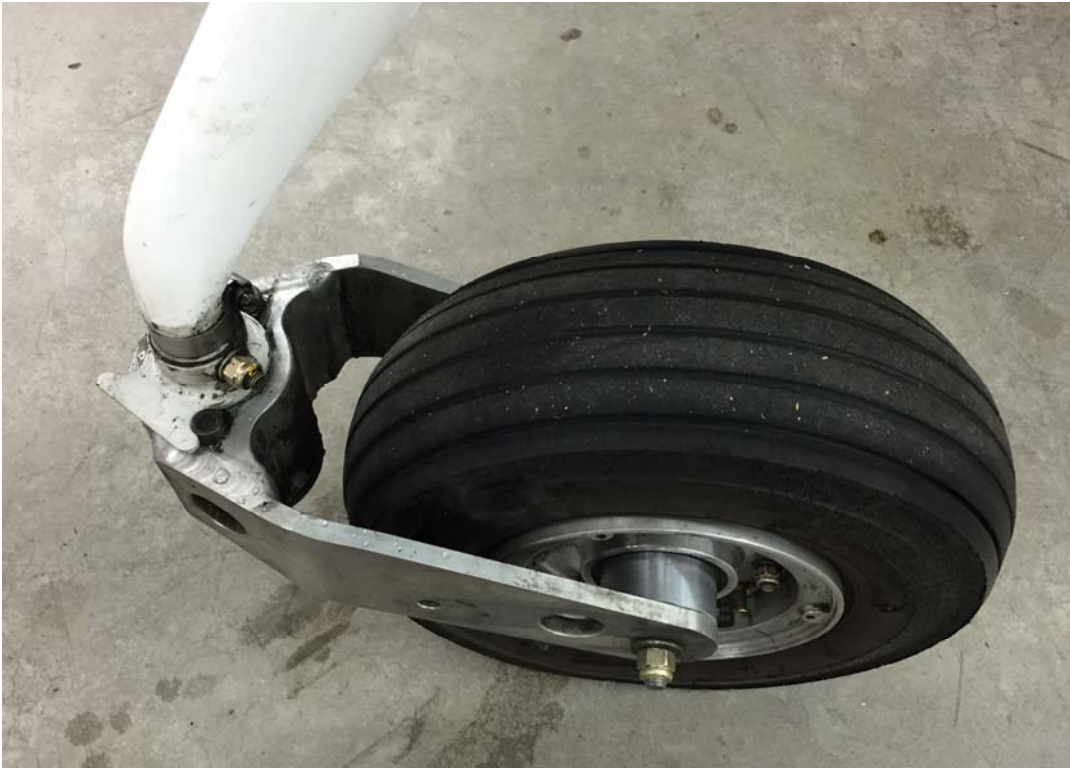
**FIGURE 2:** Nose Stop Flange Correctly Installed (Full Right Turn)

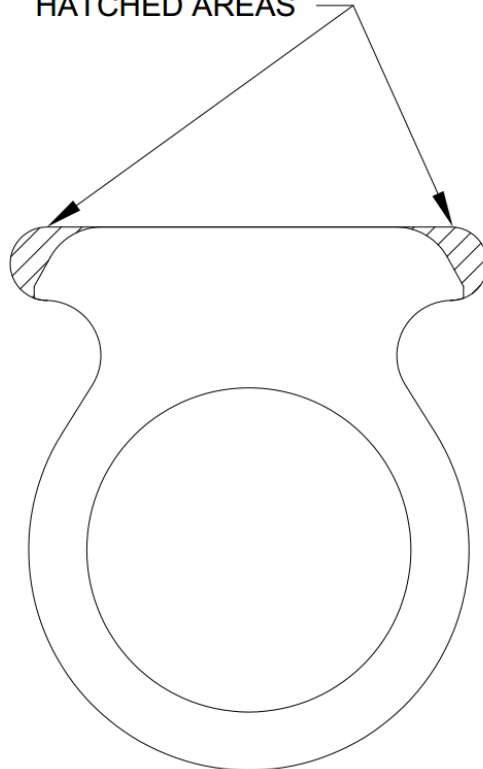
OPTIONAL REMOVE  
HATCHED AREAS

**FIGURE 3:** Nose stop flange optional trim to remove interference with nose wheel pant

Step 7: If applicable, reinstall the nose wheel pant. If the 'arms' of the stop flange interfere with the forward half of the nose wheel pant, it is permissible to remove material from the 'arms' as shown in Figure 3. Do not remove material from any part of the stop flange that contacts the cap screws mounted in the nose wheel fork.
