# SERVICE BULLETIN

Number: 97-5-1

## **Subject:** RV-4 Rear Sear Bulkhead Reinforcement

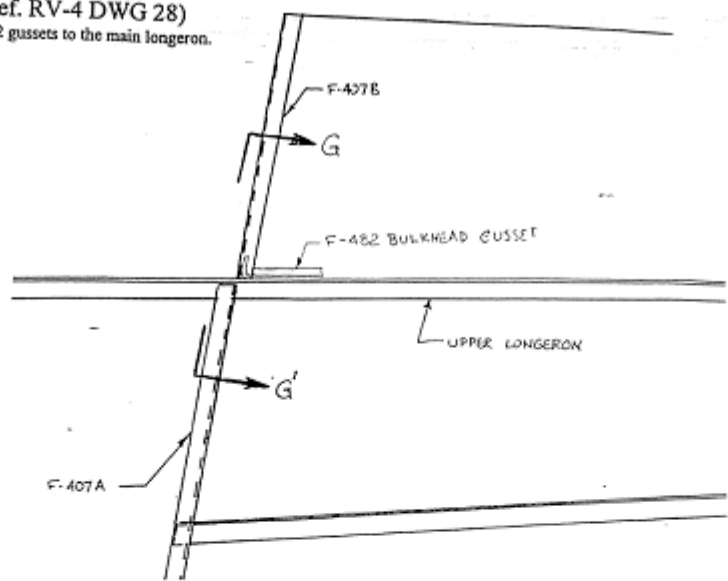
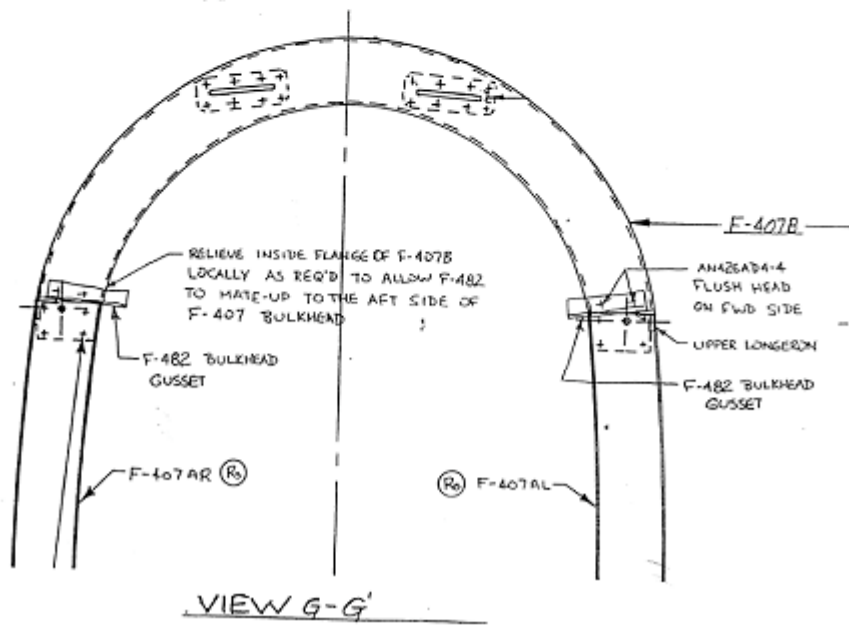
**SERVICE BULLETIN 97-5-1**  
**FIG. 1 (ref. RV-4 DWG 28)**  
 Adding the F-482 gussets to the main longeron.

The two F-482 Bulkhead Gussets (one right and one left) are installed on the upper surface of the main longeron immediately aft of the F-407 fuselage bulkhead (see Figure 1). The bulkhead gussets attach to the longeron using four AN470AD4-5 rivets per side, and to the fuselage bulkhead using two AN426AD4-4 rivets per side (see Figures 1 & 2).

The inboard flange of the fuselage bulkhead ring must be trimmed to allow the gusset to properly rest on the aft side of the fuselage bulkhead (see Figure 1).
