# VAN'S AIRCRAFT, INC.

## Service Bulletin

Number: SB 99-6-1

Applies to: RV-6 and RV-6A with overhead ("suspended") rudder pedals only.

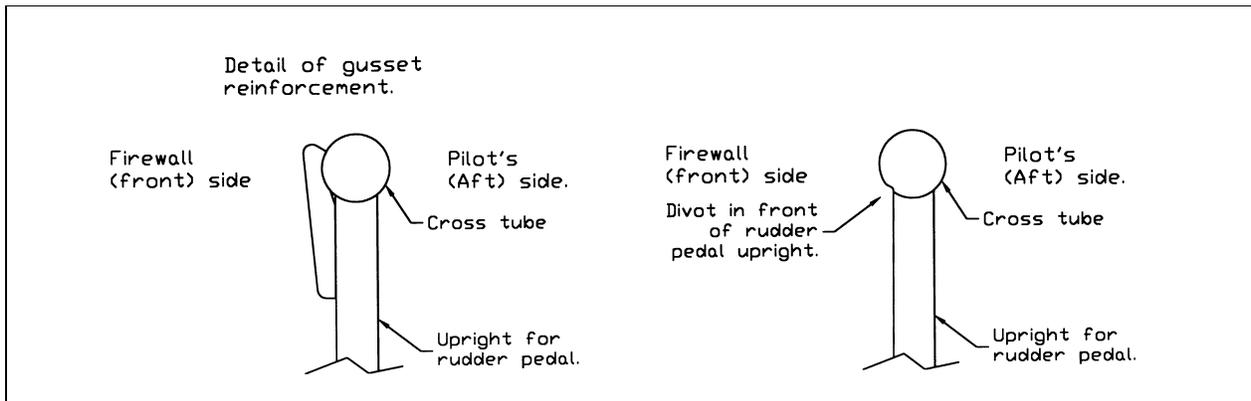
**Synopsis:** There have been several cases of welds breaking on the overhead style rudder pedals (WD-655L and WD-655R) used in the RV-6/6A. These breaks usually occur where the upright tubes from the pedal connect to the torque tube that runs across the fuselage. The forward side of the torque tube fails in compression, allowing the aft side of the torque tube to tear.

- Inspect your pedals for any sign of failure. Although it is subtle, the forward side of the tube will fail first. Check with an inspection mirror for any signs of distortion (bulging or caving in) on the forward side of the torque tubes. Also, run your fingers along the joint to feel for any distortion -- many times it is easier to feel irregularities than to see them. The pilot's right rudder pedal is the most likely to fail, but please inspect all of them.

- Owners may elect to make a permanent repair and remove the requirement for repetitive inspections. This repair may be accomplished one of two ways:
  1. Van's Aircraft, Inc. will make available, free of charge, a finger patch that may be welded on the pedals. The part number for eight patches and instructions is WD-655 FPKIT.
  2. For those owners not in a big hurry, the pedals may be returned to Van's for modification. Include a note with your name, builder's number, and shipping address. You *must* remove the paint around the tubing intersections (about 4" in all directions from the joint) before sending them in. Mark the outside of the box "RMA-WD-655". We expect repairs to take between two and four weeks but it may take longer.
