VAN'S AIRCRAFT

NOTIFICATION 18-01-24

Subject: F-1204M Rollers

Affected Models: RV-12 Fuselage kits shipped prior to Feb 2018.

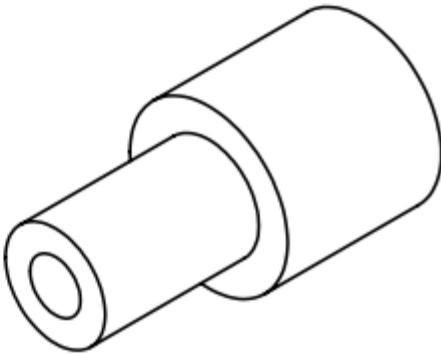
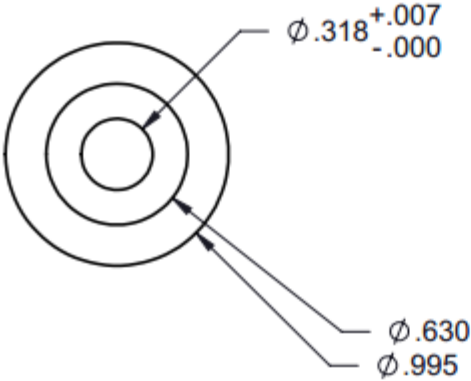
FIGURE 1: New Roller Dimensions

Wing spar manufacturing tolerances and the diameter of the F-1204M Rollers may misalign the wing and fuselage spar pin attach bushings. This may make insertion of the wing spar pins difficult. A reduction of the spar pin roller diameters will insure that worst case manufacturing tolerances will not inhibit insertion of the wing spar pins.

Step 3: Purchase new F-1204M Rollers Rev 2 or higher, or modify the outside diameters of the rollers removed from the aircraft to the dimensions shown below in Figure 1.
