SERVICE BULLETIN 00053

Date Released:	February 16, 2022
Date Effective:	February 16, 2022
Subject:	Tailcone Skin Stiffening Clips
Affected Models:	RV-12, RV-12iS
Required Action:	Inspect lower tailcone skin for cracks and install new tailcone stiffener clips
Time of Compliance:	Within 100 hours or at the next 12-month inspection, whichever occurs first
Supersedes Notice:	N/A
Labor Required / SLSA Warranty Allowance:	2.4 hours
Level of Certification:	SLSA: LSA Repairman Maintenance or A&P ELSA: Owner (certification not required) <i>Check the rules of the local controlling authority/agency and the operating limitations for your aircraft.</i>

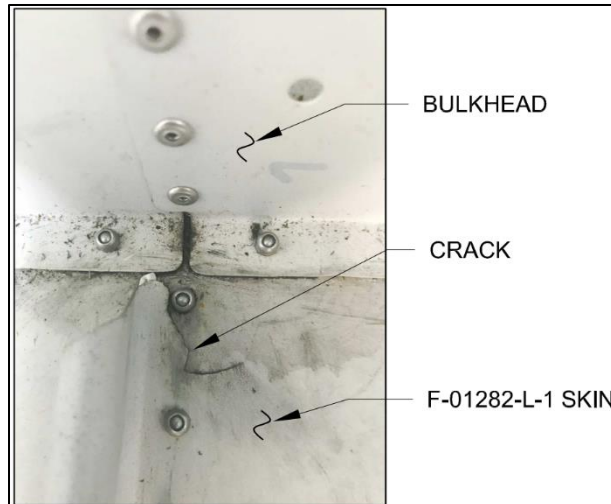
Figure 2 - Example Crack in Skin

Van's Aircraft has received reports of cracks forming in the lower tailcone skins of RV-12/12iS aircraft near the tailcone bulkheads. These cracks were observed along the centerline of the aircraft and forward of a bulkhead. Clips have been designed to stiffen these locations, thereby preventing the formation of these cracks.

NOTE: Cracks have occurred along the line of rivets connecting the F-01282-L/R-1 Skins.

Step 5: Inspect the lower fuselage skin for cracks near the F-1208, F-1209, and F-1210 bulkheads.

The clips must be installed whether cracks are present, or not. If cracks are found, an additional patch plate needs to be fabricated and installed along with the clips.

If cracks are found, stop drill the edge of each crack and fabricate a diamond shaped patch like the one shown in Figure 3, below. Fabricate the patch from .032" Aluminum Sheet.
