SERVICE LETTER 00089

Date Released:	June 17, 2024
Date Effective:	June 17, 2024
Subject:	RV-10 Wing Laser Cut Root Component Replacement
Affected Models:	RV-10 with wings containing the following laser cut parts: W-1010-L/R or W-1010-L/R-1, W-1025B-L/R, W-1029A-L/R, and W-1029B-L/R.
Required Action:	Inspect the area surrounding fastener holes in the laser cut parts for fatigue cracks—cracks propagated beyond the dimple of a flush rivet, or past the head of a universal head rivet. If fatigue cracks are present, replace the affected laser cut parts with punched parts, as outlined in this Service Letter.
Time of Compliance:	Inspect within 200 flight hours or at the next annual inspection, whichever is earlier. If fatigue cracking is not present, you may continue to comply with this Service Letter via ongoing inspection no less than every 12 months or 200 flight hours, whichever is first. Upon or before reaching 1000 flight hours, the alternate fix must be conducted as outlined in this Service Letter, at which point compliance has been met without need for ongoing inspection. If fatigue cracking is present, the modifications required by this Service Letter must be completed before fur

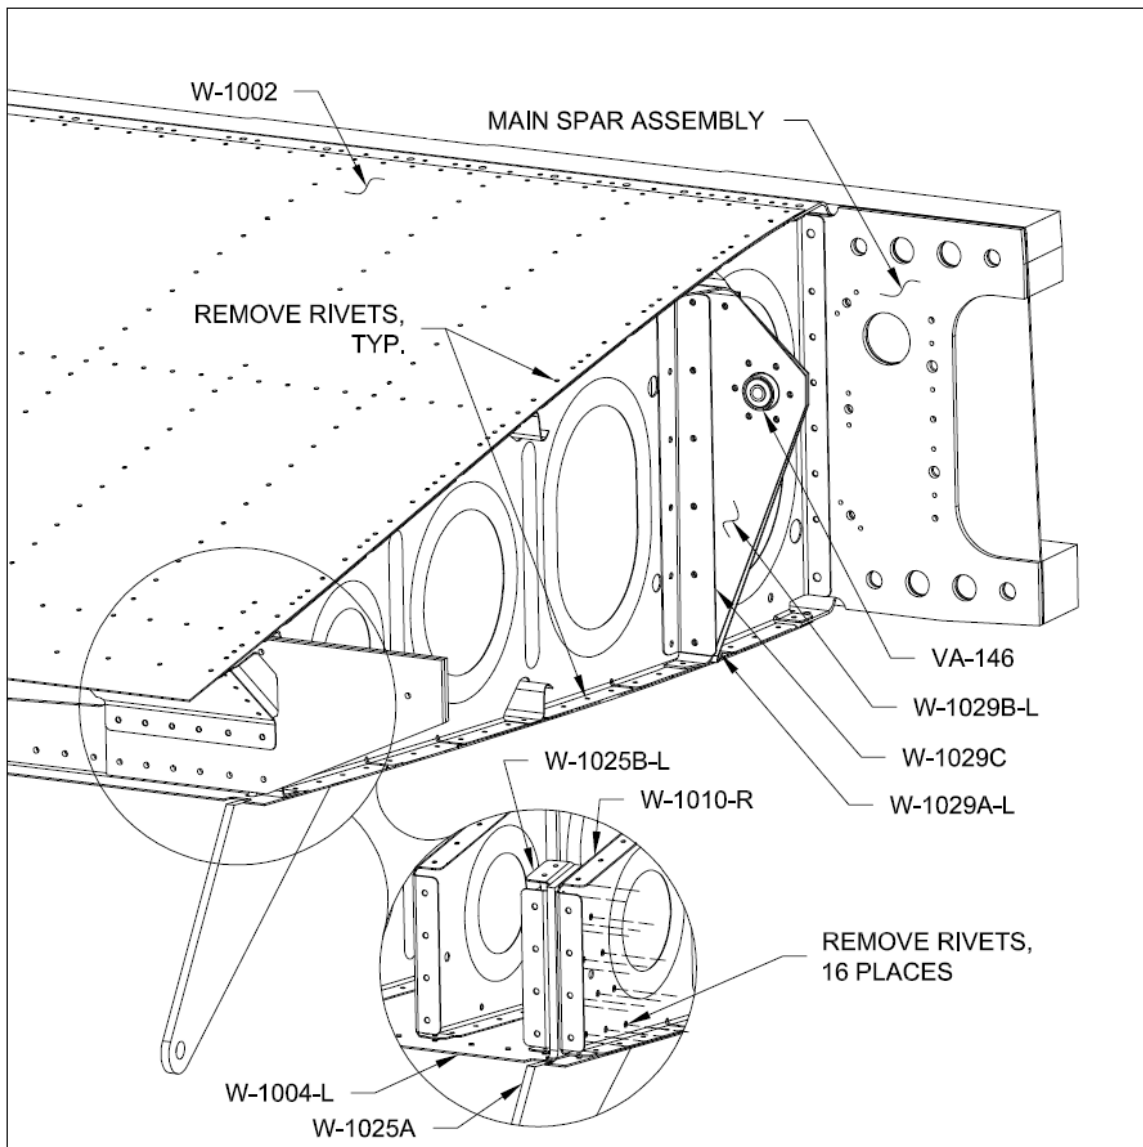
FIGURE 1: LEFT WING ROOT AREA

The W-1010-L/R (or W-1010-L/R-1) Inbd Wing Rib, W-1025B-L/R Flap Hinge Rib, W-1029A-L/R and W-1029B-L/R Torque Tube Support Brackets have been classified as Recommended for Replacement. These components are of a critical nature and/or experience occasional high load events that make them more susceptible to fatigue damage.

The listed components are to be replaced with a CNC punched component of the same part number, or the modified components included in this Service Letter. Affected wing assemblies may be at various stages of completion and contain some or all affected components. The following service information is representative of a wing assembly that has been completed and contains laser cut instances of all the components listed above. Where applicable, in-process steps may be omitted to represent the level of completion found in each individual case.

Step 6: Remove rivets fastening the W-1025A to the W-1010-R and W-1025B-L as shown in the detail view of Figure 1. Remove the W-1025A, set aside for reinstallation in a later step.

Step 7: Remove all rivets joining the W-1002 Top Inbd Wing Skin to the W-1010-R, including those common with the W-1029A-L and W-1029B-L. See Figure 1.

Step 8: Remove all rivets joining the W-1004 Bottom Inbd Wing Skin to the W-1010-R, including those common with the W-1029A-L and W-1029B-L. See Figure 1.

Step 9: Remove all fasteners joining the W-1010-R to the Main Spar Assembly. See Figure 1.
