## SERVICE LETTER 00100

<b>Date Released:</b>	June 17, 2024
<b>Date Effective:</b>	June 17, 2024
<b>Subject:</b>	RV-14 Fuselage Laser-Cut Parts Remediation
<b>Affected Models:</b>	RV-14 fuselages constructed with a laser-cut F-01405A  RV-14A fuselages constructed with a laser-cut F-01405A, and/or F-01451-L/R, and/or F-01448A and/or F-01448C-L/R
<b>Required Action:</b>	Inspect the aforementioned parts for fatigue cracks propagated from fastener holes. In many places, cracks will not be visible until they have propagated beyond the flanges of overlapping parts. If cracks are present, replace the laser-cut parts with a punched part. If cracks are not present, install the alternate fix detailed below.
<b>Time of Compliance:</b>	Inspect within 200 flight hours or at the next annual inspection, whichever is earlier.  If fatigue cracking is not present, you may continue to comply with this Service Letter via ongoing inspection no less than every 12 months or 200 flight hours, whichever is first.  Upon or before reaching 1000 flight hours, the alternate fixes must be conducted as outlined in this Service Letter, at which point compliance has been met without need for ongoing inspection.

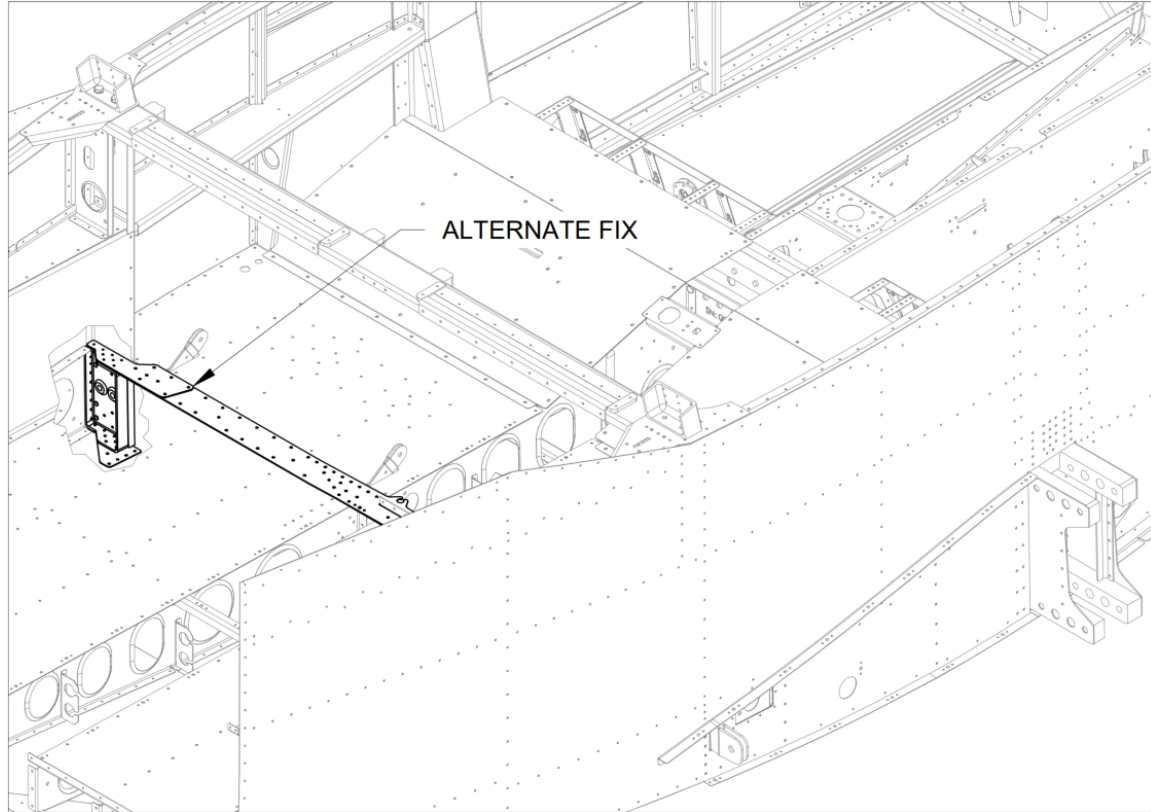
**FIGURE 1:** F-01405A ALTERNATE FIX OVERVIEW

In the RV-14 and RV-14A, the F-01405 Bulkhead Assembly is a highly-loaded section of the fuselage structure built upon the F-01405A Bulkhead Bottom Channel; classified as Recommended for Replacement. Replacement of the F-01405A would be very involved on a flying aircraft, a QuickBuild Kit, or a Standard Kit that has progressed past Section 25 of the KAI (Kit Assembly Instruction). However, an alternate fix has been developed, restoring the structure to as-good or better structural strength and durability in service, with a drastically reduced workload. Installation of the alternate fix is outlined in Section 1 of this Service Letter, with an overview shown in Figure 1.

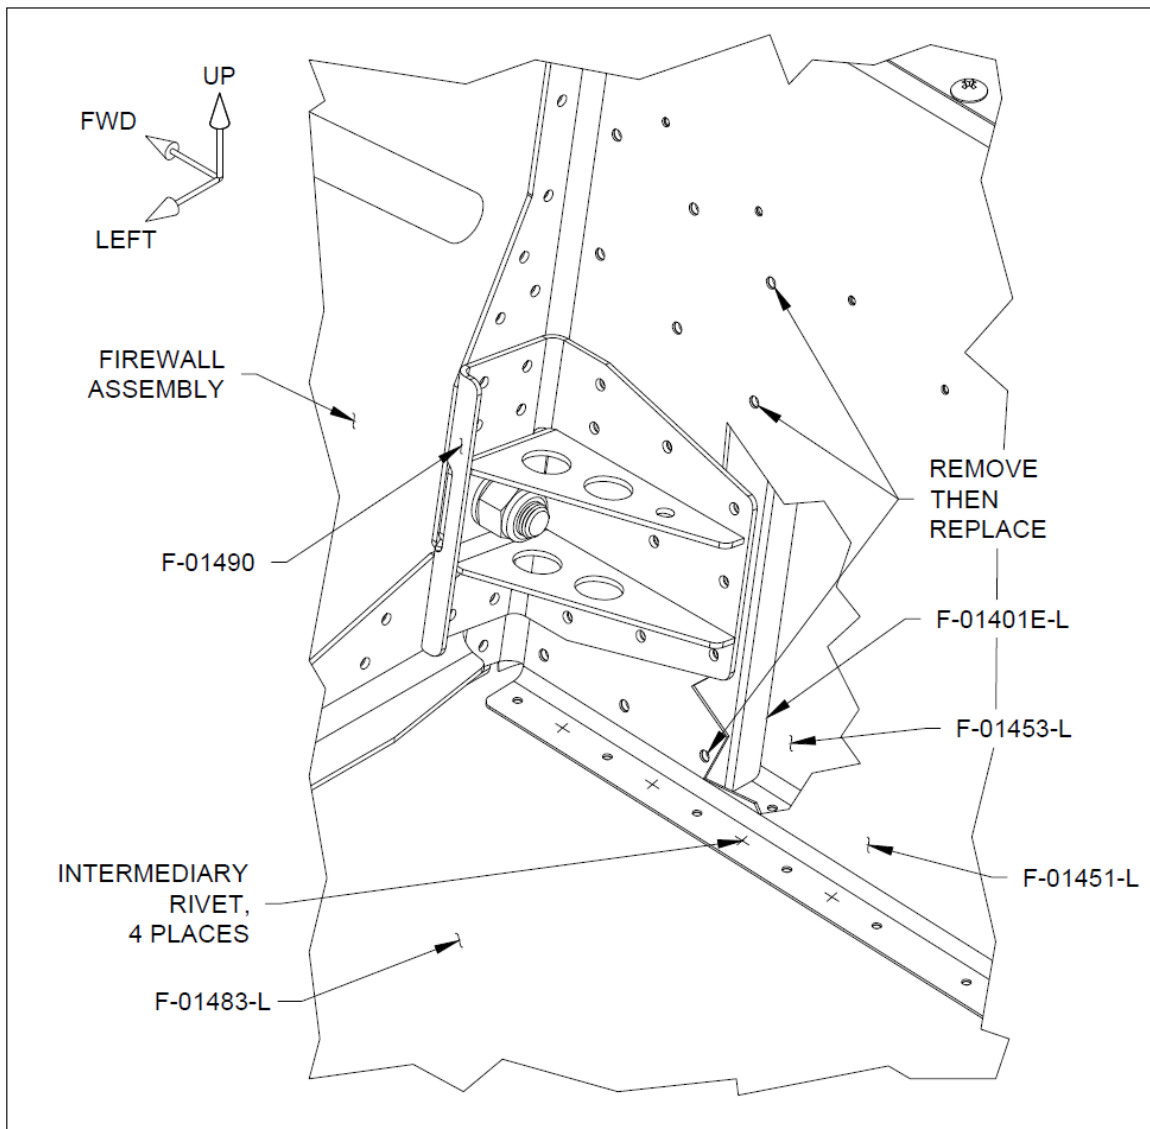
**FIGURE 13:** FIREWALL ASSEMBLY AND TUNNEL SIDE  
(SHOWN WITHOUT OP-62 MODIFICATIONS)

In the RV-14A, the Tunnel is a highly-loaded section of the fuselage structure built upon the F-01451-L & -R Tunnel Side; classified as Recommended for Replacement. Select rivets in the Firewall Assembly which attach the F-01451-L/R Tunnel Side, F-01401E-L/R Firewall Angles, and F-01483-L/R Forward Bottom Skin see particularly high loads and are the area of concern for the assembly with regards to laser cut part fatigue. Replacement of the F-01451-L/R would be very involved on a flying aircraft, a QuickBuild Kit, or a Standard Kit that has completed Section 28 of the KAI (Kit Assembly Instruction). However, an alternate fix has been developed, restoring the structure to as-good or better structural strength and durability in service, with a drastically reduced workload. Installation of the alternate fix is outlined in Section 2 of this Service Letter.

Step 53: Remove the three rivets called out in Figure 13 that join the F-01451-L Tunnel Side and the F-01401E-L Firewall Angle. A drill-stop is recommended to prevent damage due to the limited clearance between the tunnel side and underlying F-01453-L Muffler Shroud Side.

Step 55: Replace the removed rivets with CR3213-5-2 blind rivets. Reference Figure 13.

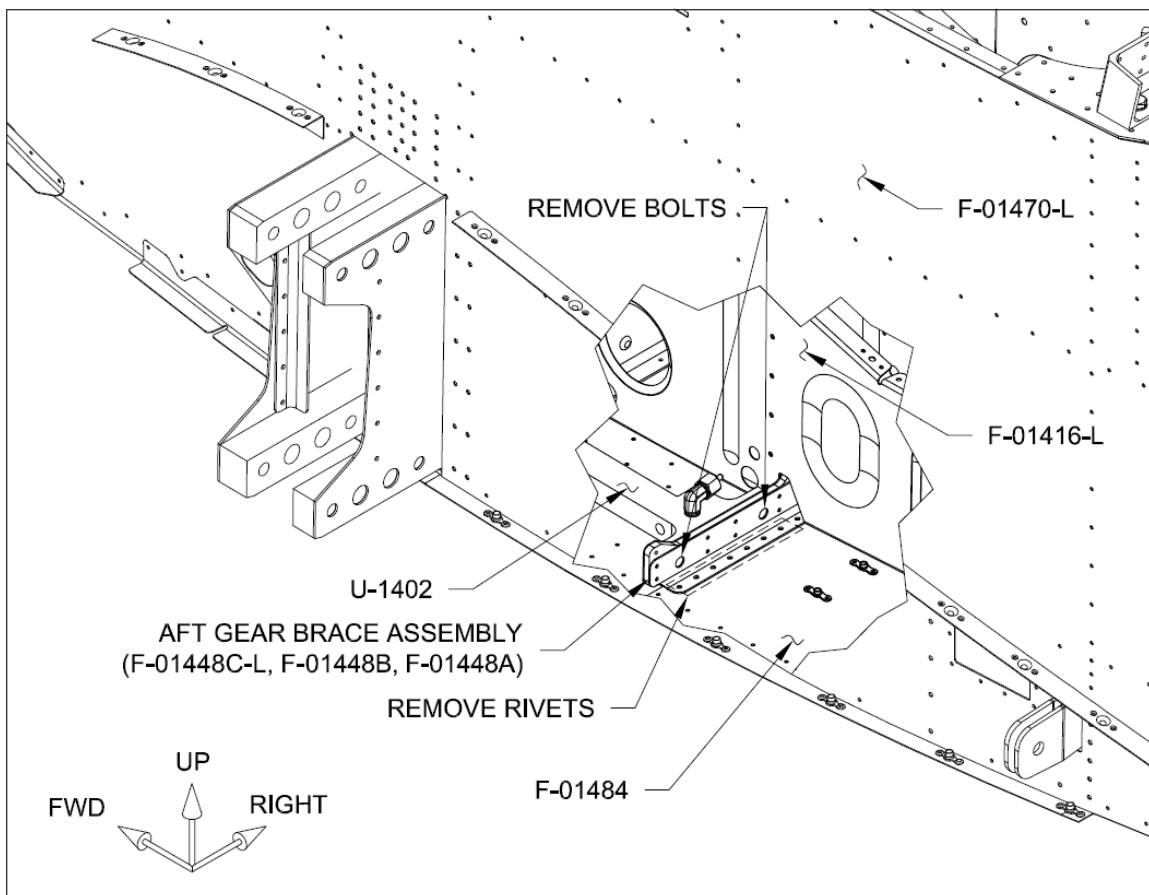
**FIGURE 17:** REMOVING HARDWARE FROM AFT GEAR BRACE ASSEMBLY

In the RV-14A, the Aft Gear Brace Assembly is a highly-loaded section of the fuselage structure, tied into the surrounding structure by the flanges of the F-01448A Gear Brace Angle and F-01448C-L/R Gear Brace Bracket; classified as Recommended for Replacement. Replacement of the F-01448A and/or the F-01448C-L/R would be very involved on a flying aircraft, a QuickBuild Kit, or a Standard Kit that has progressed past Section 26 of the KAI. However, an alternate fix has been developed, restoring the structure to as-good or better structural strength and durability in service, with a drastically reduced workload. Installation of the alternate fix is outlined in Section 3 of this service letter.

Step 68: Remove the two bolts securing the U-01402 to the Aft Gear Brace Assembly, as called out in Figure 17.

Step 69: Remove the seven outboard rivets attaching the Aft Gear Brace Assembly to the F-01484 Center Bottom Skin, as called out in Figure 17.
