SERVICE LETTER 00105

Date Released:	January 7, 2025
Date Effective:	January 7, 2025
Subject:	Pitot Tube Bushing Adhesion
Affected Models:	All RV-12 and RV-12iS aircraft RV-12iS SLSA Serial Numbers 12003, 12076-12168
Required Action:	Inspect bushing for adhesion failure and replace if necessary
Time of Compliance:	At or before the next annual condition inspection
Supersedes Notice:	N/A
Labor Required:	1.5 Hours
Level of Certification:	SLSA: LSA Repairman Maintenance or A&P ELSA: Owner (certification not required) <i>Check the rules of the local controlling authority/agency and the operating limitations for your aircraft.</i>

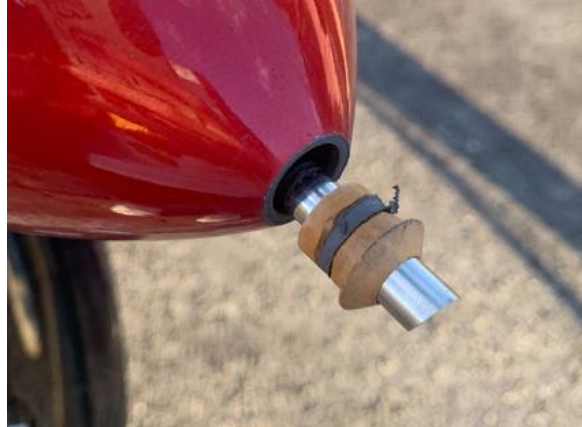
Operators of RV-12 and RV-12iS aircraft have found pitot tube bushing adhesive failures in the field. Using epoxy to adhere the bushing provides a more secure bond.

FIGURE 1: ADHESIVE FAILURE EXAMPLE

Step 1: Inspect the S-1207 Bushing for adhesive failure. See Figure 1. If the bushing can rotate freely (by hand) or falls out of the spinner, proceed to Step 2 otherwise skip to Step 7.

Step 2: Remove the Spinner from the aircraft. See section 47, 47iS/U or 47AiS/U.

Step 3: Remove the Bushing. If necessary, drive the bushing out from the aft side of the Spinner using a 7/16" diameter dowel. Take care not to damage the fiberglass.

Step 4: Remove any residual tank sealant or other adhesives from the Spinner. Prepare the surface of the new S-1207 Bushing and hole in the nose of the spinner with alcohol and 220 grit sandpaper.

Step 5: Following manufacturer instructions, prepare West Systems 105 epoxy and 205 fast hardener, or equivalent, and apply evenly to the bushing mating surfaces.

Step 6: Insert the Bushing into the Spinner. Remove any excess epoxy with a clean, lint-free cloth. Allow the epoxy to cure fully before re-installing the Spinner on the aircraft.
