| MID FUSE SIDE SKINS AND STRUCTURE | | |
| DATE: DRAWN: 8/12/05 | UNITS: INCHES | RV-8 / 8A |
| | | DWG 69 |

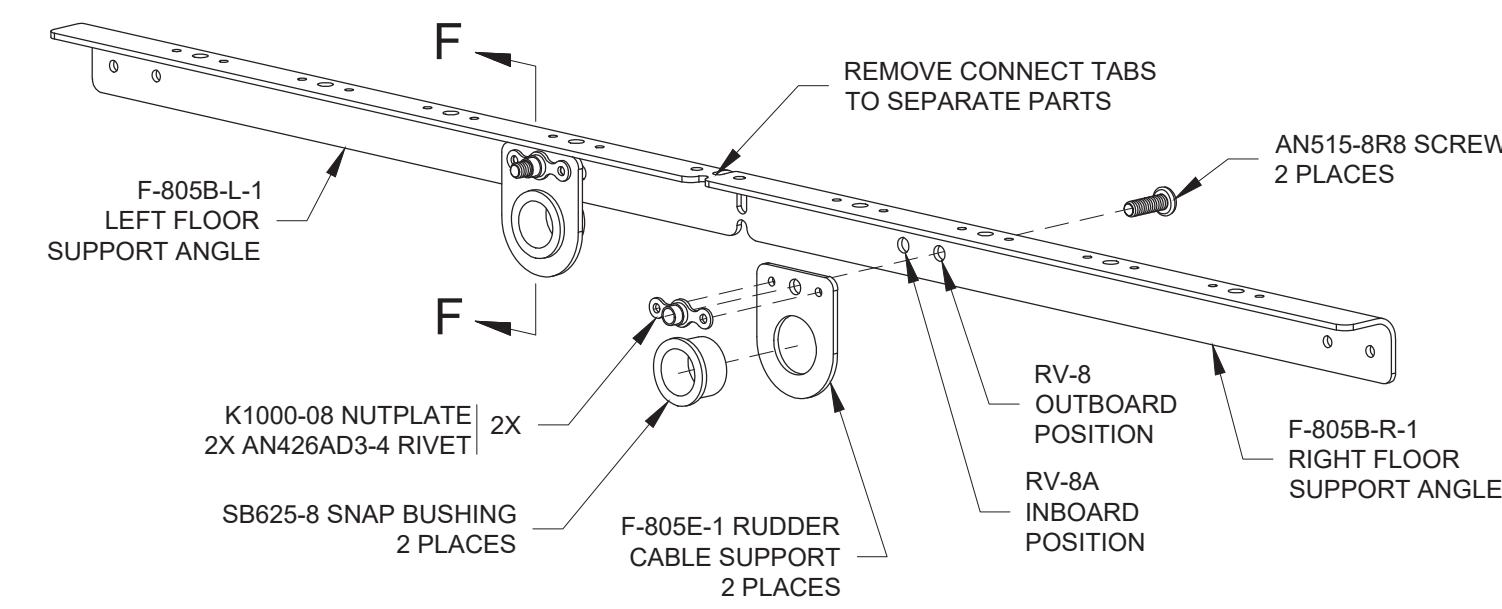
F-805B-1 FLOOR SUPPORT ANGLE DETAIL

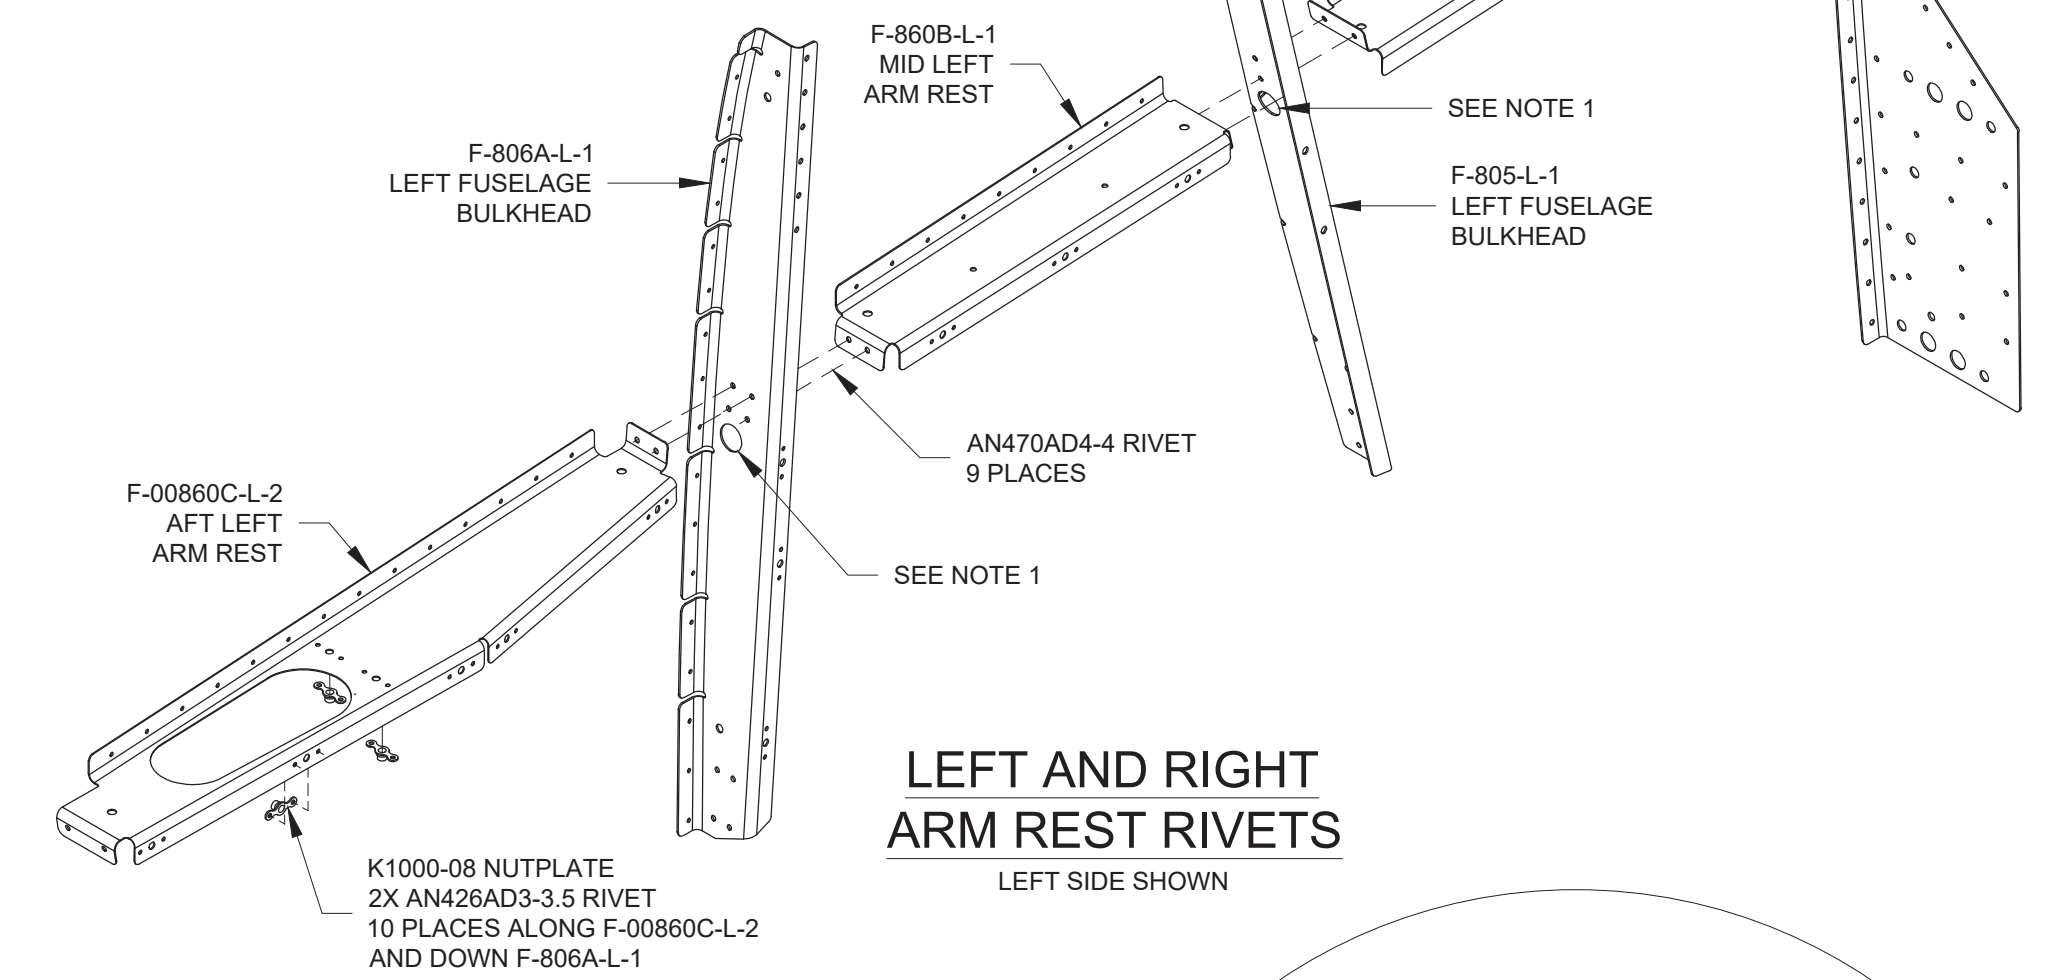
LEFT AND RIGHT  
ARM REST RIVETS  
LEFT SIDE SHOWN

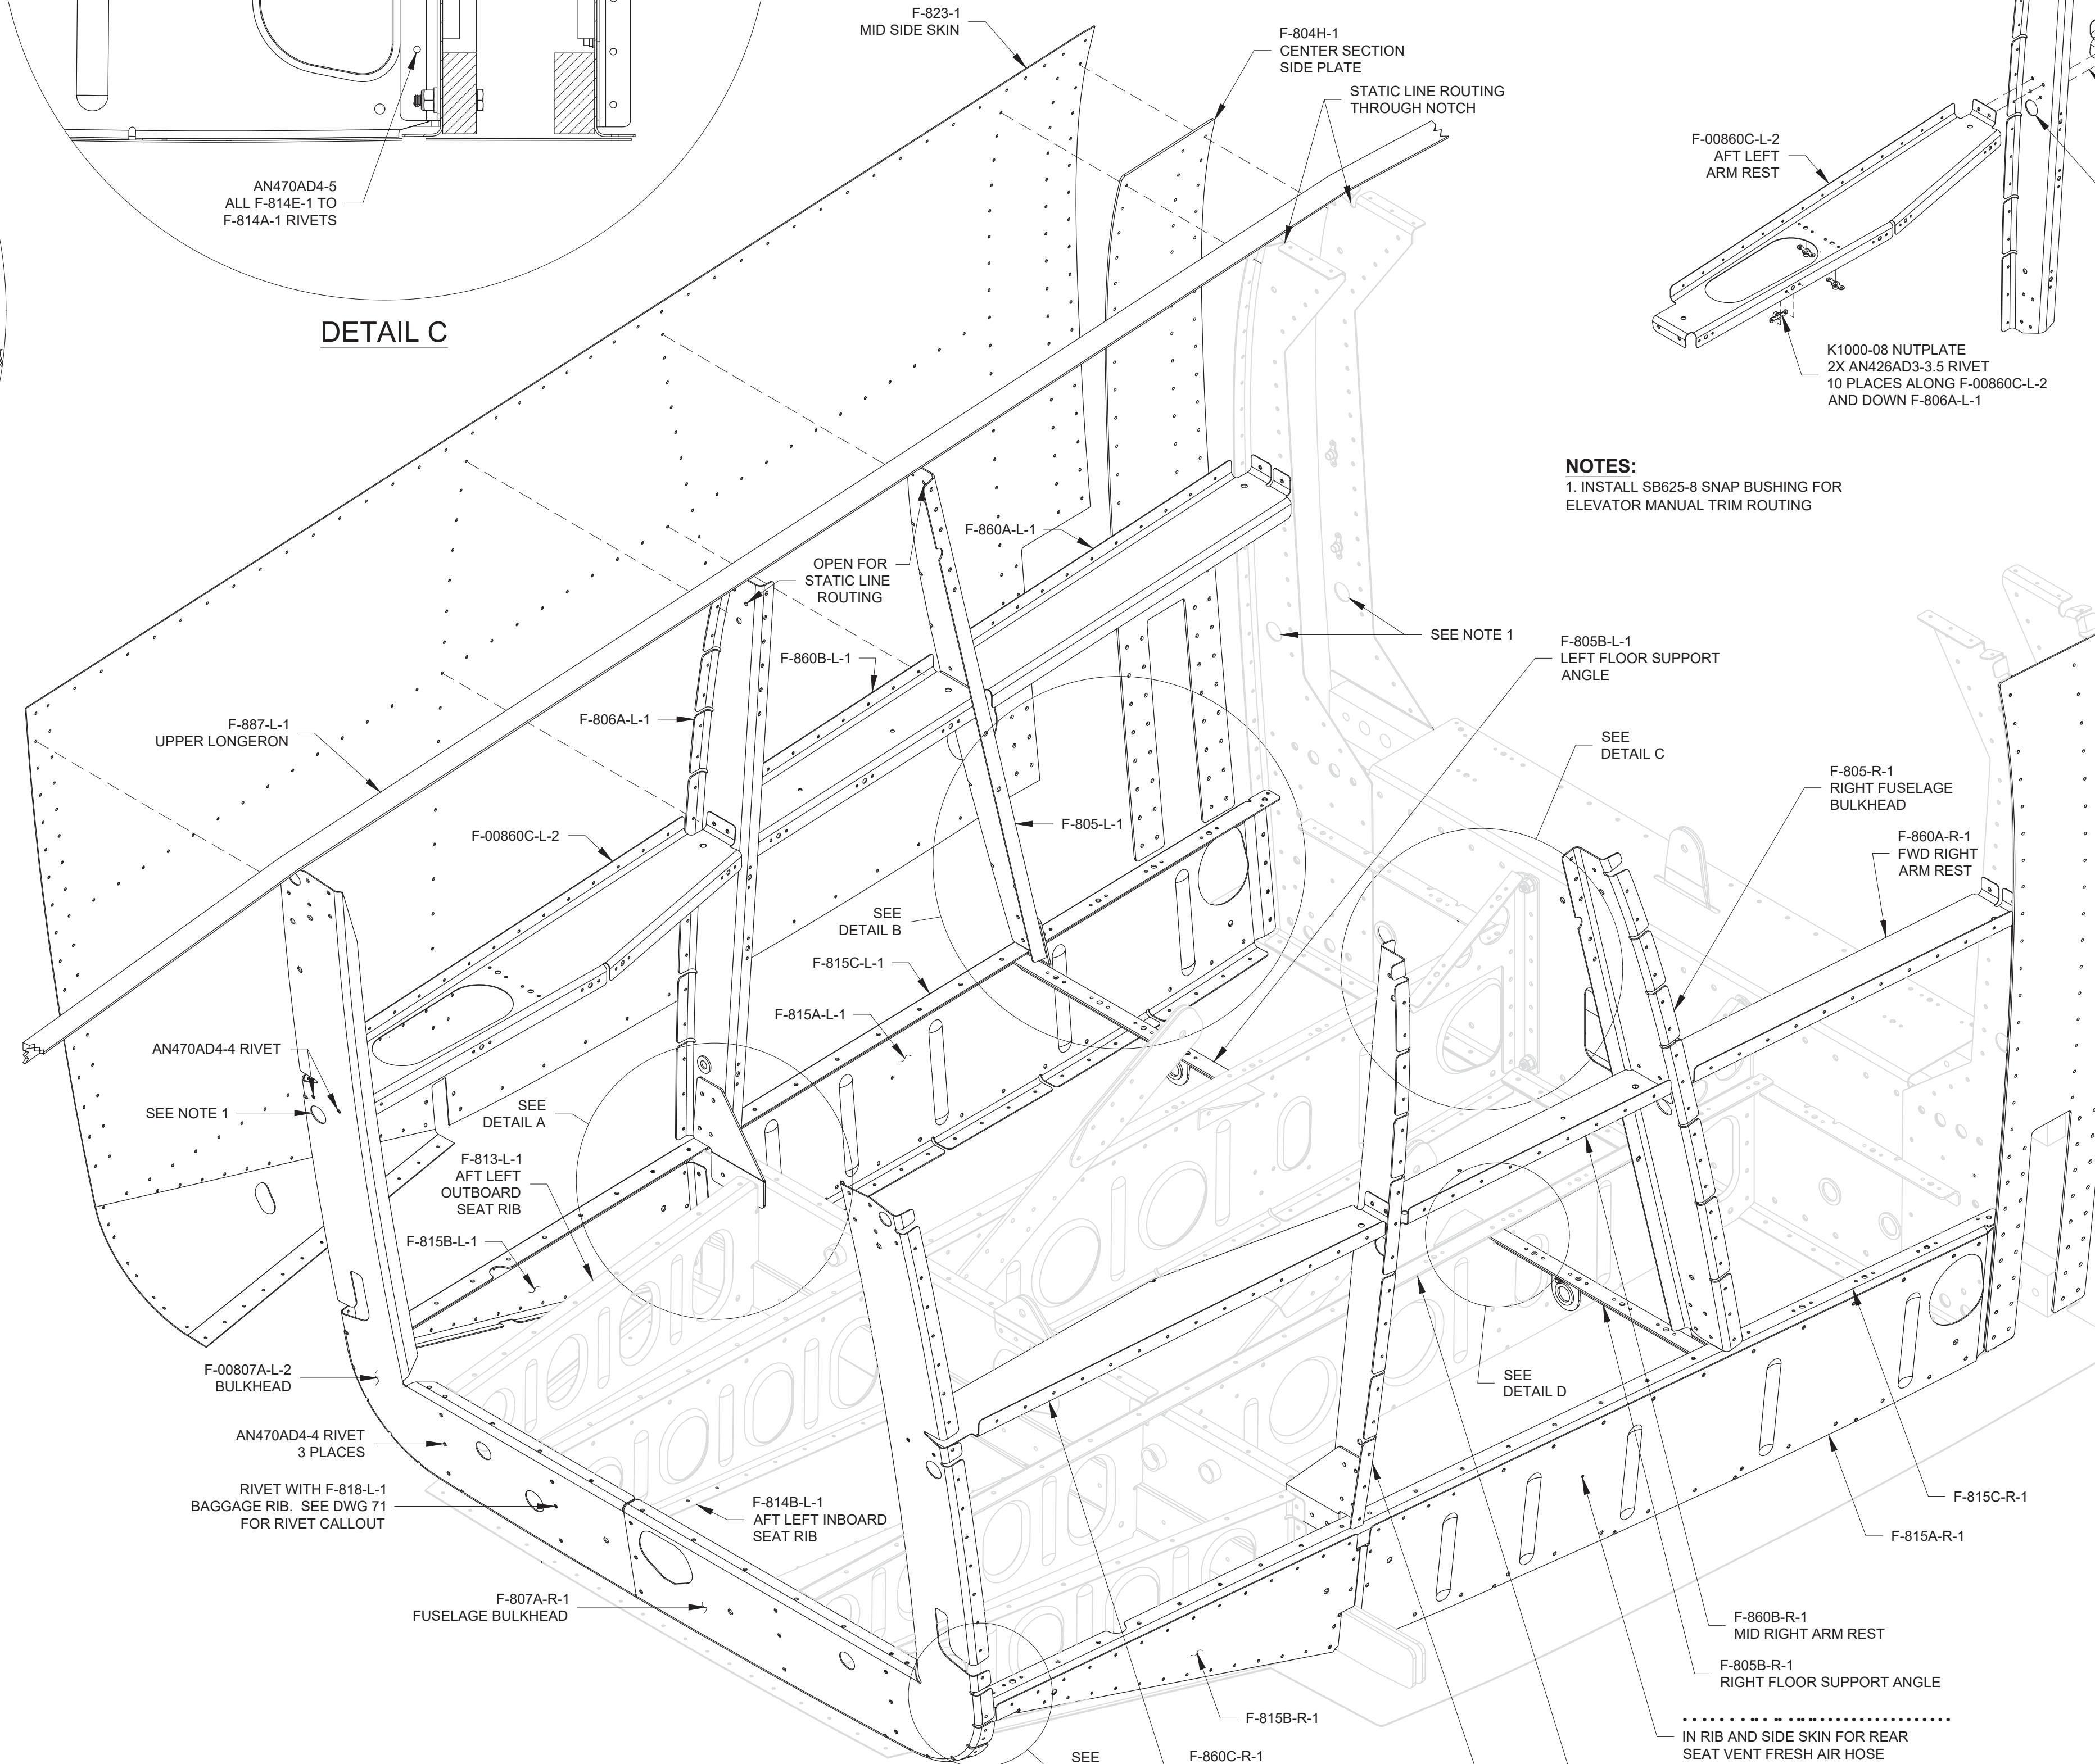
MID FUSE SIDE SKIN AND STRUCTURE

RIVET CALL-OUTS SYMMETRICAL ABOUT AIRPLANE CENTERLINE  
SOME PARTS NOT SHOWN FOR CLARITY

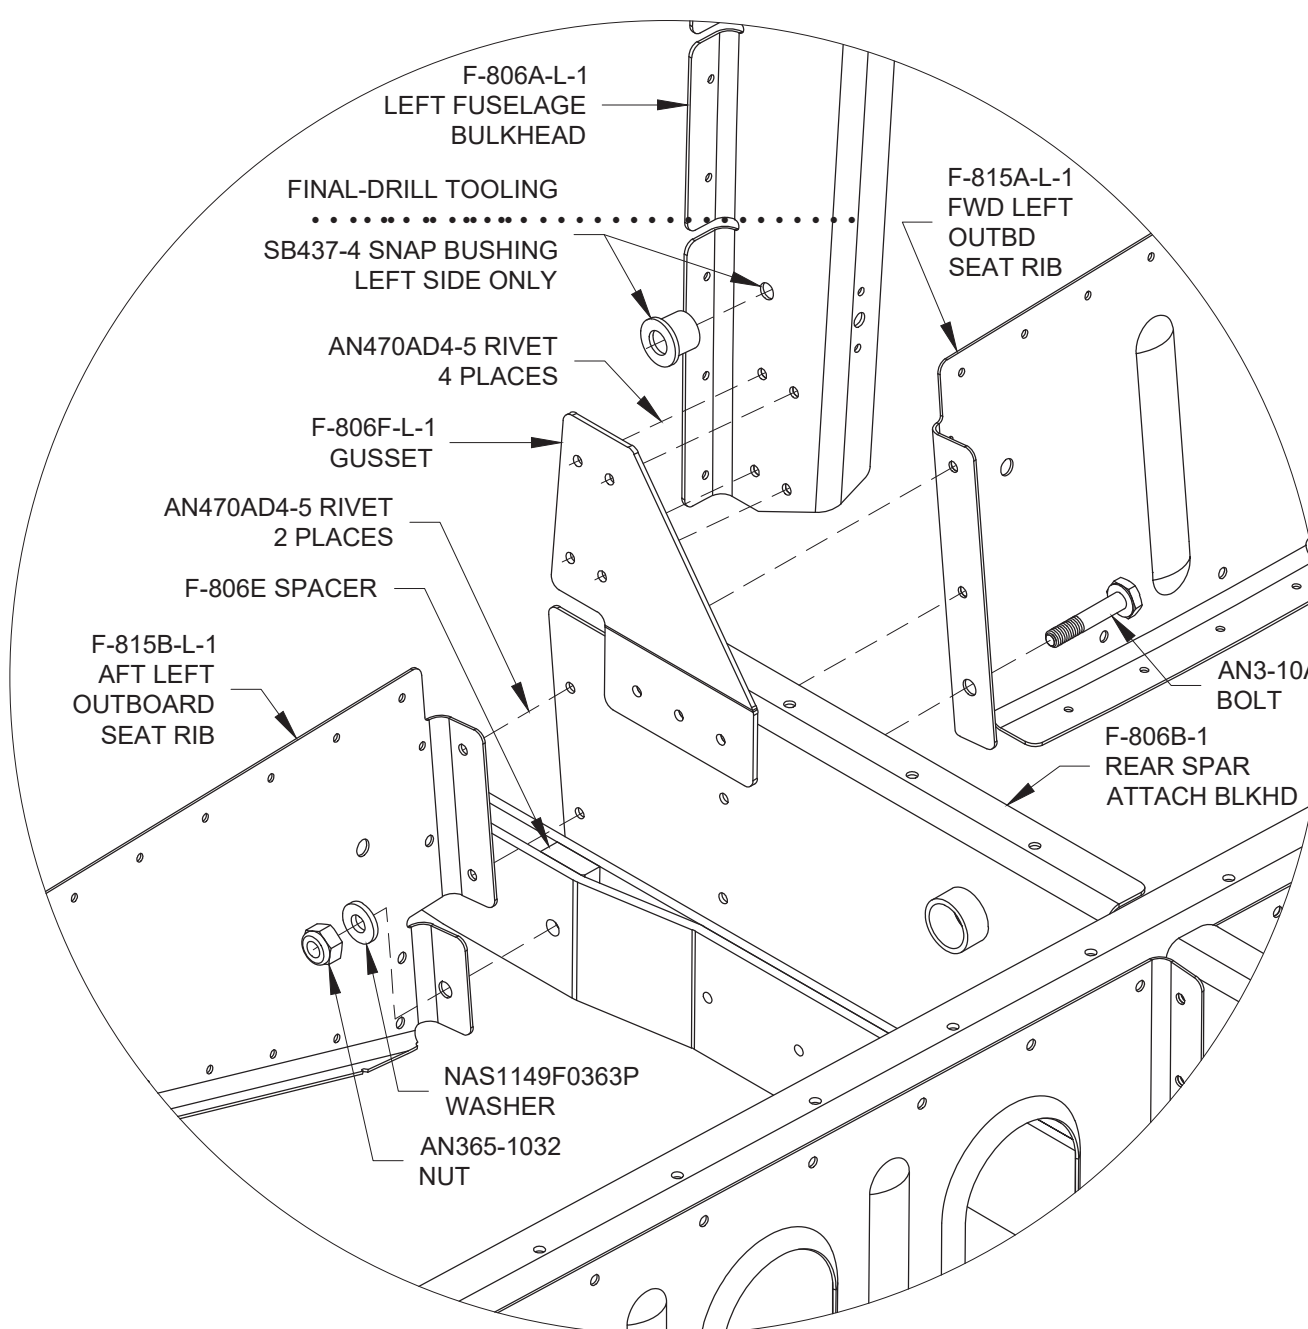
DETAIL A

F-813-L-1 NOT SHOWN FOR CLARITY
